DHR Inventory No: \_\_\_\_\_  
 Temporary Survey No: 1  
 Community/county Whitefield/Coos

address Rte. 116  
 property name James House-Lakeview Academy  
 tax map/parcel no. 7 #20  
 UTM ref Z 19 E 289580 N4913660 Bethlehem  
 resource type (code) House  
 Dominant Style (code) Federal/Greek Revival  
 Secondary Style (code) Colonial Revival  
 Condition (code) good  
 Construction Date (source) c. 1830  
 Alteration Date(s) c. 1920

#1 James House-Lakeview Academy - c. 1830, 1 1/2 story, altered cape in transitional Federal/Greek Revival style with added shed dormers, Colonial Revival style porch and 2 1/2 story, Colonial Revival style addition. Stone and concrete foundation, asphalt shingle roof, clapboard siding. Sash is 12/12, 6/6 and modern with 6/1 on c. 1920 addition with symmetrically molded trim. Entrance on main block features 4-panel door with 1/2 length sidelights surmounted by multilight transom and flanked by pilasters with entasis. Porch c. 1920 features square columns on clapboarded half-wall. West facade of main block overlooking pond has much modern alteration.

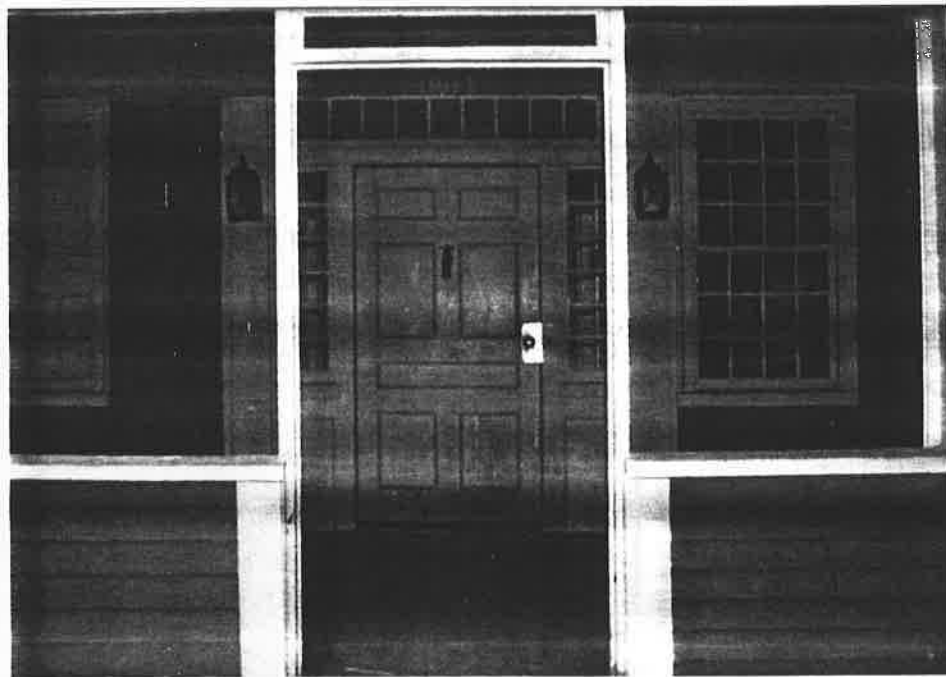
The James House-Lakeview Academy is important in preserving the essential Federal/Greek Revival style characteristics of an early Cape, which is rare in the survey. The pilastered entrance is noteworthy. The land was originally deeded to Montgomery on the c. 1816 plat map. The house was occupied by O. M. James in 1861 and 1892. It was most recently occupied by Lakeview Academy. It is vacant and is for sale. The desirable frontage on Burns Pond and the 26 acres in common ownership make further development of the site inevitable. It is representative of the early agricultural settlement patterns of the community.

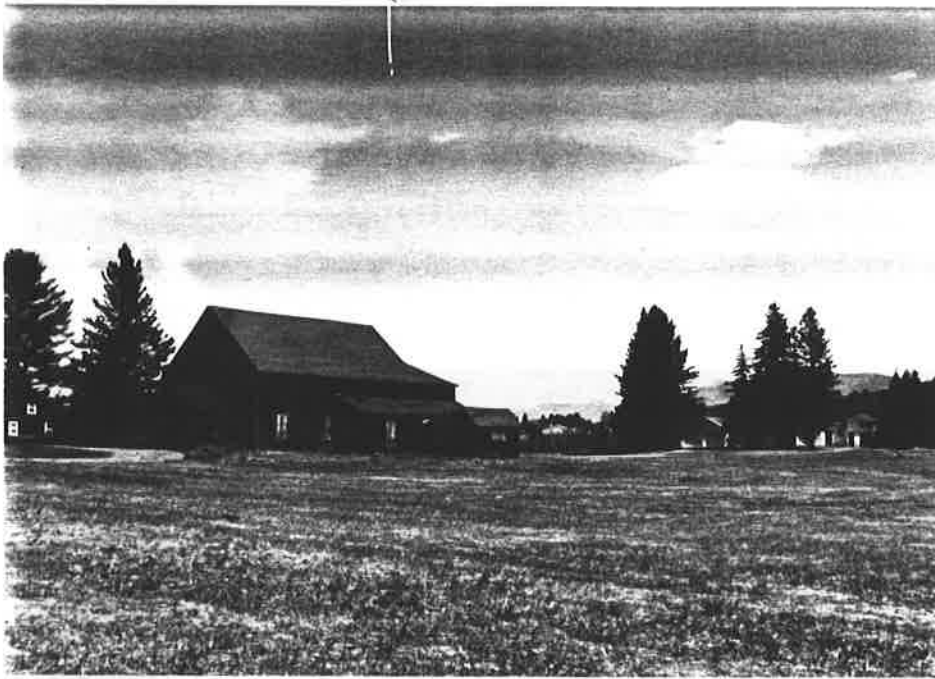
#10

The farm was begun in 1850 under the ownership of Hon. Aurin M. Chase, who built the Homeplace (#12). In 1889, when the farm was owned by son Austin Chase, these former farm fields were used for the site of the visiting Barnum and Bailey Circus which brought 16,000 people to the property on nearby excursion trains. The Chase Barn Playhouse was begun in 1937 by William Chase, retired music/drama critic for the New York Times and grandson of the farm's founder. It continued (with short stoppages during wars) until 1962 under the leadership of William Chase's neice, Lucy Chase Sparks. #10d, Lucy Chase Sparks house, was built for her by her uncle. The theater ran eight plays during the summer season as well as an apprentice school for aspiring actors. The Chase Barn's Equity Company was hired by taking a suite at the Biltmore Hotel and auditioning hundreds of people for the ambitious undertakings at the well reknowned summer theater. The complex presently consists of 15.2 acres under ownership of three Chase family descendents.

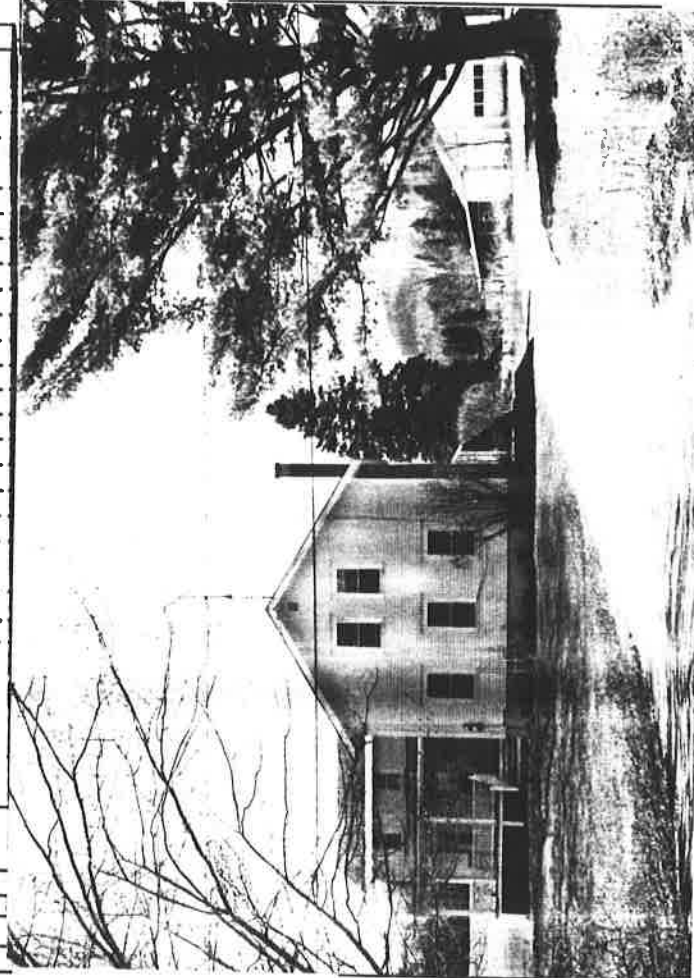
photographer facing W  
 photograph date: 4/88  
 photo code(s): DN-45-88 #12

#11 Austin Chase House - c.1920, 2 story, gable front, Colonial Revival/Craftsman style residence has 2 story gable roofed ell with Colonial Revival style porch and 1 story rear shed roofed wing. Asphalt shingle roof, clapboard siding and concrete faced foundation. Plain cornerboards, simple eaves with exposed molded rafter tails. Sash is 6/6 with cap moldings. Entrance in 2 story ell. Porch has Doric columns, simple balustrade and exposed molded rafter tails. Rear wing shows evidence of former privy with small sash.

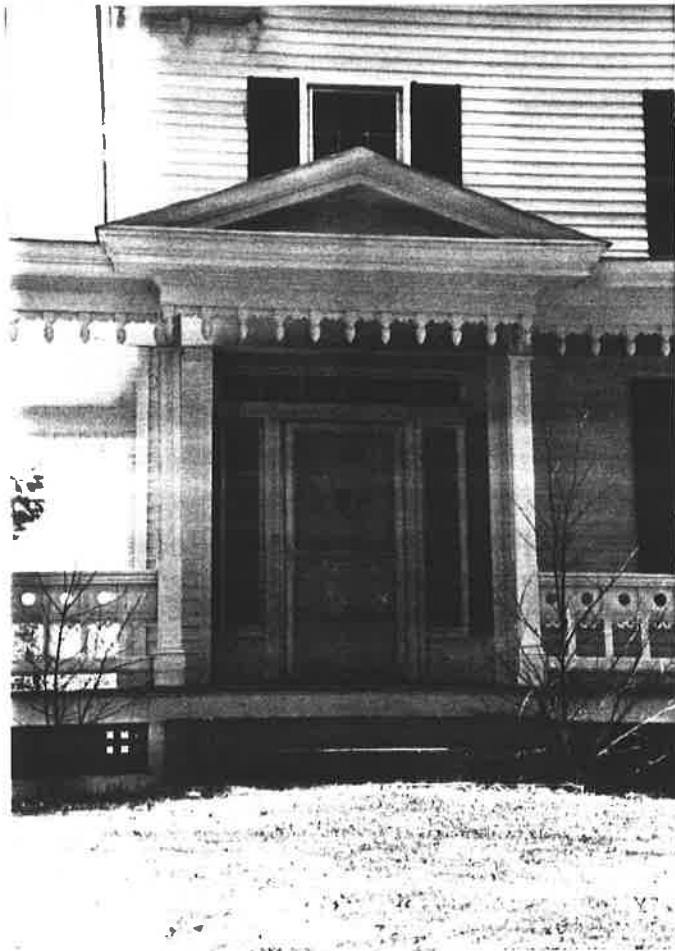
#12 Chase - "The Homeplace" - Ruoss House - 1850, 2-1/2 story, 3x3 bay sidehall Greek Revival style residence with Queen Anne veranda and 2 story rear wing. Clapboard siding, substitute siding front facade obscures some detail, granite block foundation. Sash is 6/6, some with cap moldings on secondary facades, louvered wood shutters. Articulated with panelled corner pilasters, wide frieze and molded box cornice with gable returns. Cornice noteworthy for unique turned pendants under eaves. Entrance recessed in panelled surround has 4 panel door, 3/4 sidelights, multilight transom. Late 19th century veranda wraps around gable front and features polygonal open corner turret: square columns with "triple bead" motif, cut-out balustrade, latticework apron and pendanted cornice (pendants have different profile as compared to those on eaves cornice of main block). 2 story rear wing has asphalt shingle gable roof, plain cornerboards, molded box cornice with gable returns, rear wood exterior staircase sheltered by shed roof, and 1 story, shed roofed porch with square posts on south eaves facade.

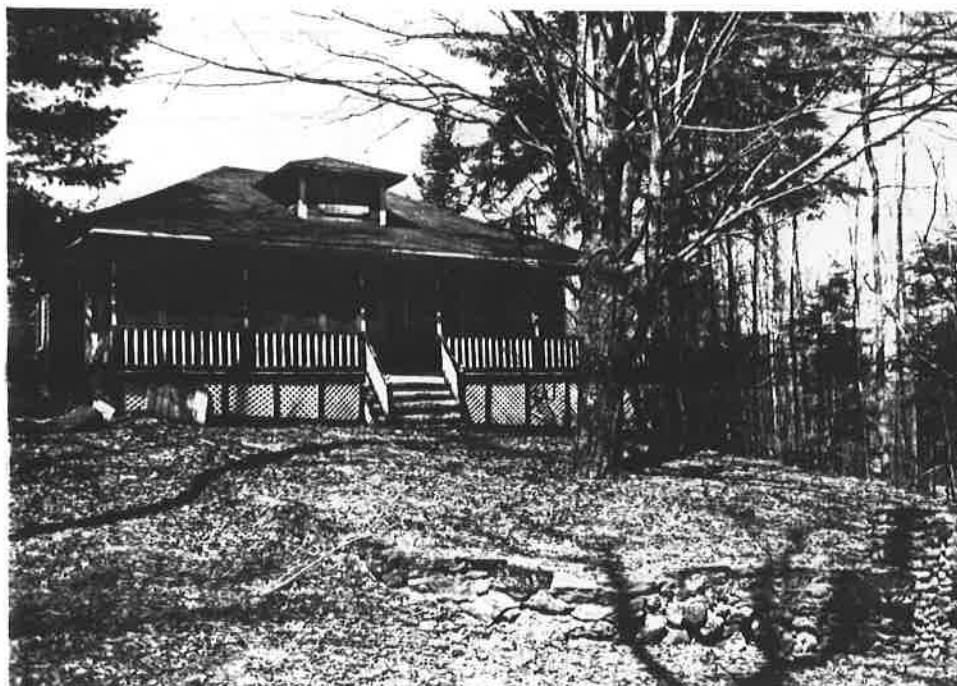
a. Preston House - c. 1915, 1-1/2 story, 7 bay front, Bungalow dwelling with asphalt shingle hip roof, new clapboard siding. Overshot porch front facade features turned Queen Anne style posts. 1/1 sash, new stained glass in hipped dormer. c. 1980 rear gable roofed wing.

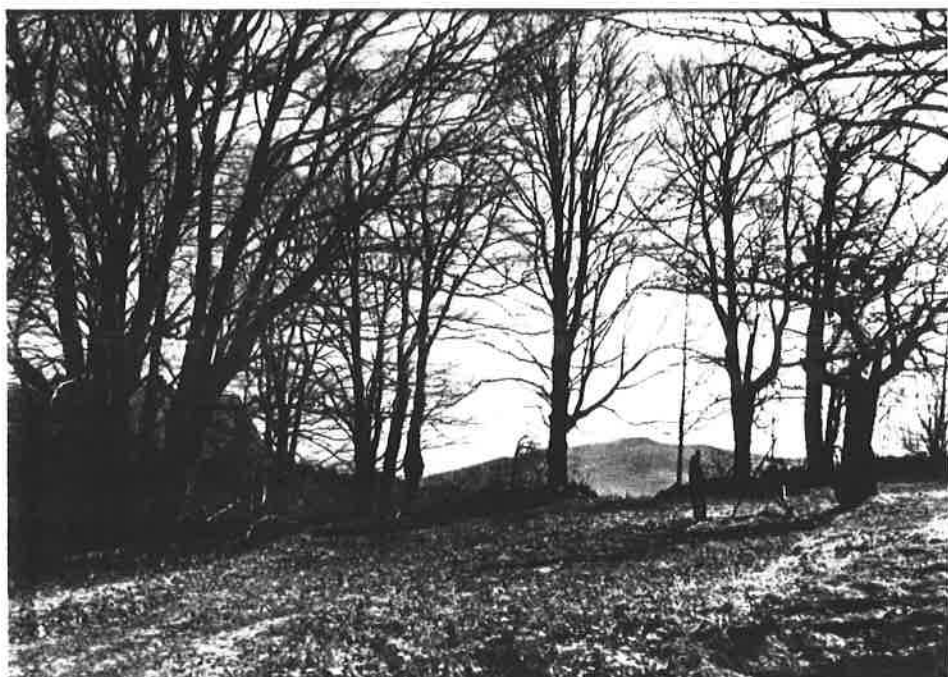
#19

This early cape dwelling exhibits early Federal style architectural details which is rare in the Whitefield survey. It is outstanding in maintaining its original integrity as a farm homestead with original field patterns representative of the first wave of settlement of hill farms in the town. It appears that H. Kimball may have been the original grantee of the property. The land was purchased by Harris in 1822 and a log home erected on the west side of the road (now gone) soon after. The main block of the house was built c. 1833, with the wing constructed c. 1845. The property was owned by A. Harris in 1861, G.A. Harris in 1892, and currently remains in the Harris family. There was evidently a home founded by Mother Hutchins, who laid out the first Methodist circuit in the area, located on a portion of the property in c. 1813. Together with the other properties on Kimball Hill Rd., an intact rural district is formed which preserves most of the 19th c. field patterns.

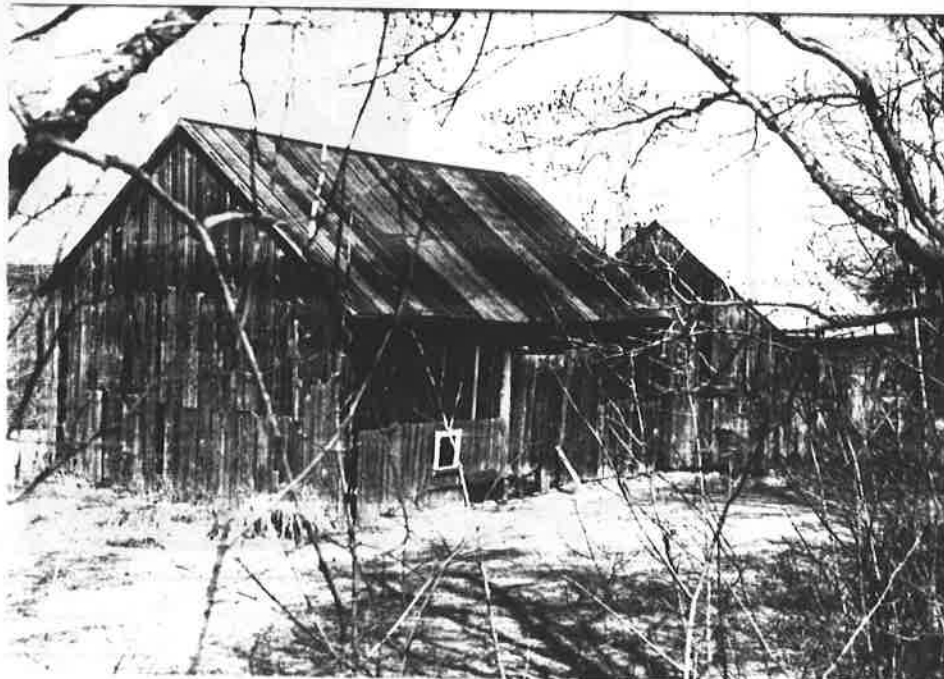
#20 a + b

The Harris log cabin is one of two Adirondack style log homes in the survey (see #10) and is significant as an example of the survival of diversified small scale agriculture into the 20th century. The cabin is on the site of an older dwelling (since demolished) that was originally associated with the remaining barns. It is related to #19 in that the property is part of the Harris home farm. The map of 1861 indicates that A. Harris owned two houses, one of which appears to have been at this location. The Map of 1892 shows only #19, which was owned by G.A. Harris, indicating that the dwelling on this site may already have been torn down. The original plat map of c. 1816 shows that Holt Kimball owned the property before the Harris family bought the home farm in 1822. The original house on this site may have been one built by Kimball. Together with the surrounding land, the image of a hill farm with intact field patterns is preserved. In conjunction with the other properties on Kimball Hill Road, a rural district with original 19th century field patterns is maintained.

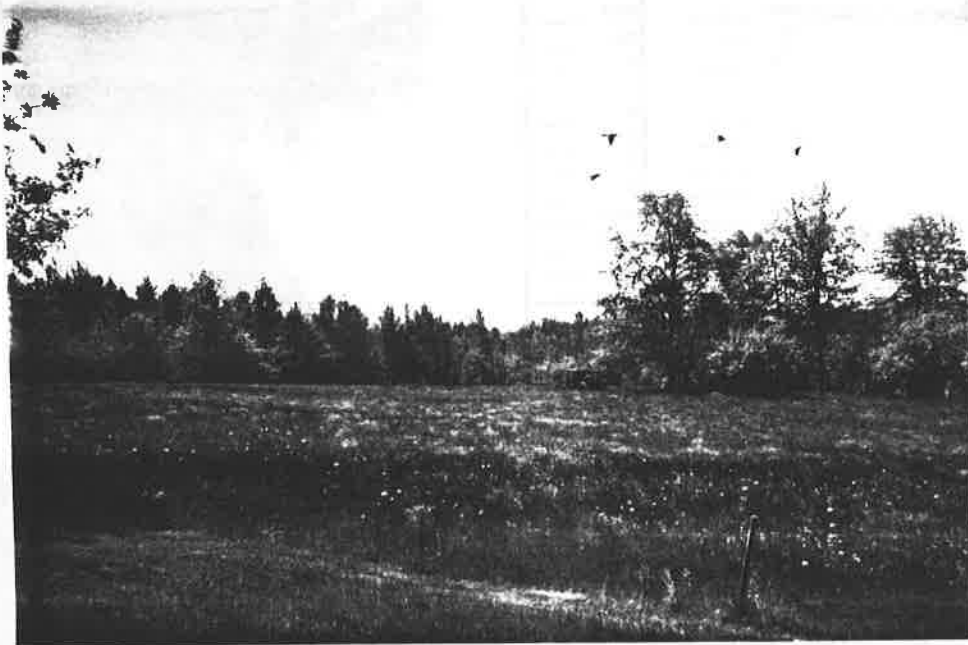
#31 Couturier House - c. 1925, 1-1/2 story, 3x2 bay, gable roof, with gable roofed porch wing off S gable end. Wood shingle siding, fieldstone foundation. Sash is 8/1 with plain trim and slat shutters. Wide eaves overhang is beaded tongue and groove. Exterior fieldstone chimney and principal entrance N gable end. Gable roof dormer faces SW-views of Franconia Notch.

The Couturier house is significant in combination with the sensitive landscape plantings and historic field patterns probably associated with the former farm located across Bray Hill Rd. and occupied by S.G. Evans in 1861 and M.L. Fletcher in 1892. Scenic views of Franconia Notch are extensive to the southwest. This property maintains the original hill farm setting of the Bray Hill area of Whitefield, which is experiencing some subdivision. These are the only combination of fields, some of which are not in common ownership with the house, which remain as open space in this area.

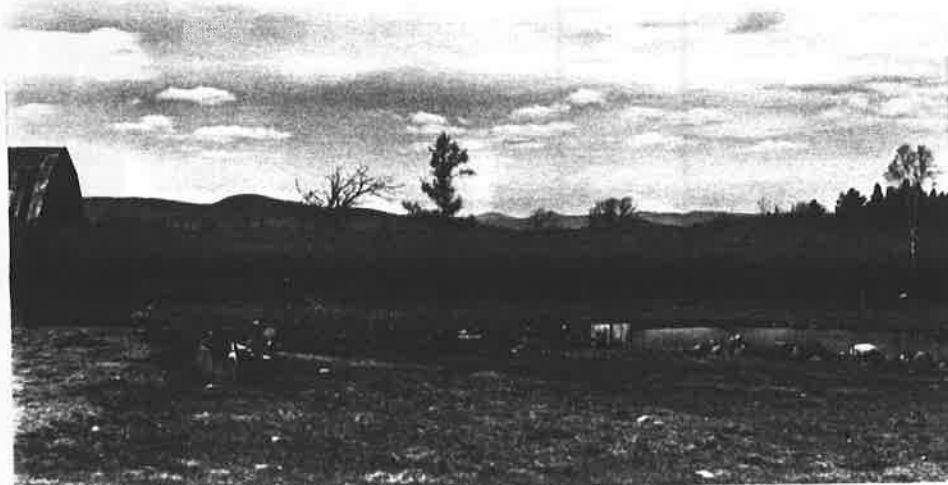
#37

Although the former early cape dwelling has lost integrity through alteration, the working farm complex encompasses an important historic cultural landscape cleared by one of Whitefield's early settlers. Col. Joseph Colby came to Whitefield from Lisbon in 1816, locating upon "Comstock Hill" where he carved out the nuclei of the Lane-Bean Farm (#36) and the Dieterich Farm (#35). The acreage extended to this portion of what later became known as Colby Road and it is assumed that Colby sold off the above-mentioned portion of the land and settled in the area of #37. In 1861 Joseph Colby occupied 2 farms on the present Colby Road and in 1892, one of the farms was owned by C. F. King and the other by R. O. Colby. Portions of the 169 acres in common ownership are rated as prime agricultural soil.

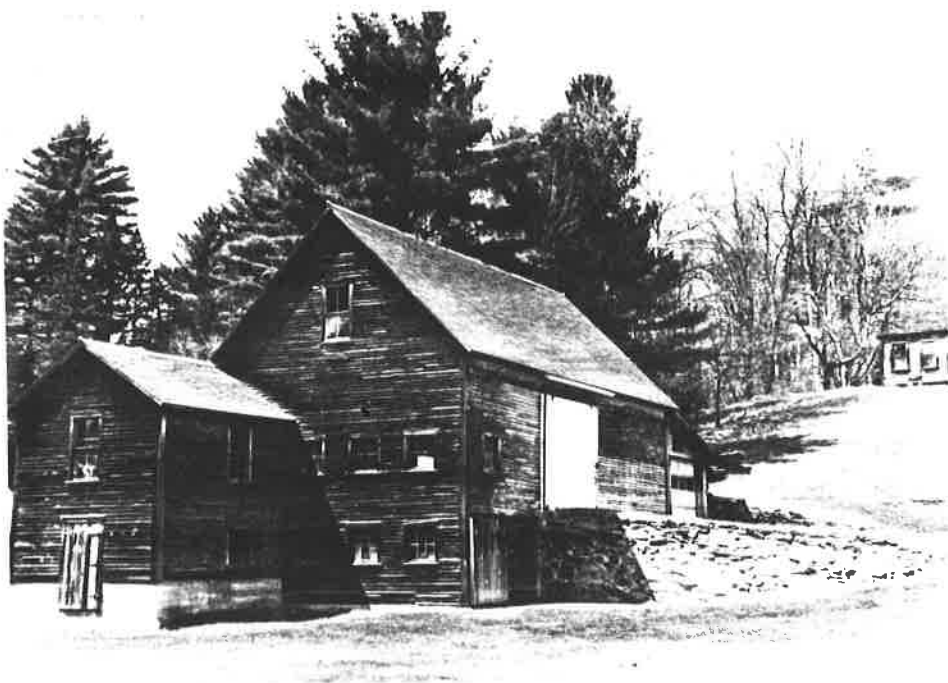
44  
a.

a. barn - c. 1890, 2-1/2 story with smaller 1-1/2 story wing S gable end. Gable roof, clapboard siding, stone foundation. Wide frieze and plain box cornice. Single 6 and 2/2 sash. High drive to center eaves facade (E). Recent shed roofed garage N. gable end.

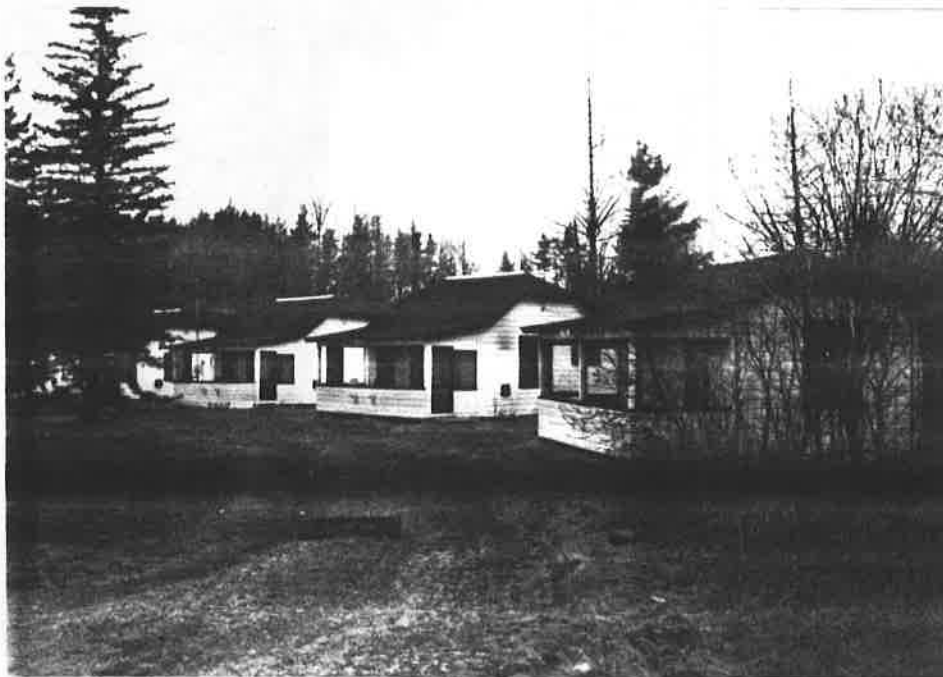
a - e

#65 Hale-Robbins-Whitefield Lakeside Condominium - c. 1830, 1 1/2 story, cape house with hip roofed dormer, gable roofed entrance porch and shed roofed eaves porch, both in the Queen Anne style. Clapboard siding, asphalt shingle gable roof. Plain cornerboards, frieze and molded cornice with gable returns. Replacement sash is 2/2 with plain trim, some non-original grouped. Principal entrance on gable end has 7/8 length sidelights. Porches feature turned Queen Anne posts, open brackets and simple balustrade.

The Hale-Robbins house is important as an early Cape dwelling, which architectural form is rare in the survey. It is important in exemplifying the various periods of significance through which it has evolved, including an outlying hill farm from the first period of agricultural settlement in Whitefield, an office for a group of roadside-lake cabins c. 1935, and now the pivotal structure for the group of buildings as they are recycled as condominiums. The house is on land owned by Hale on the c. 1817 plat map, was occupied in 1861 by J. Hale, and in 1892 by C. H. Robbins. It retains its overall integrity despite various period alterations.

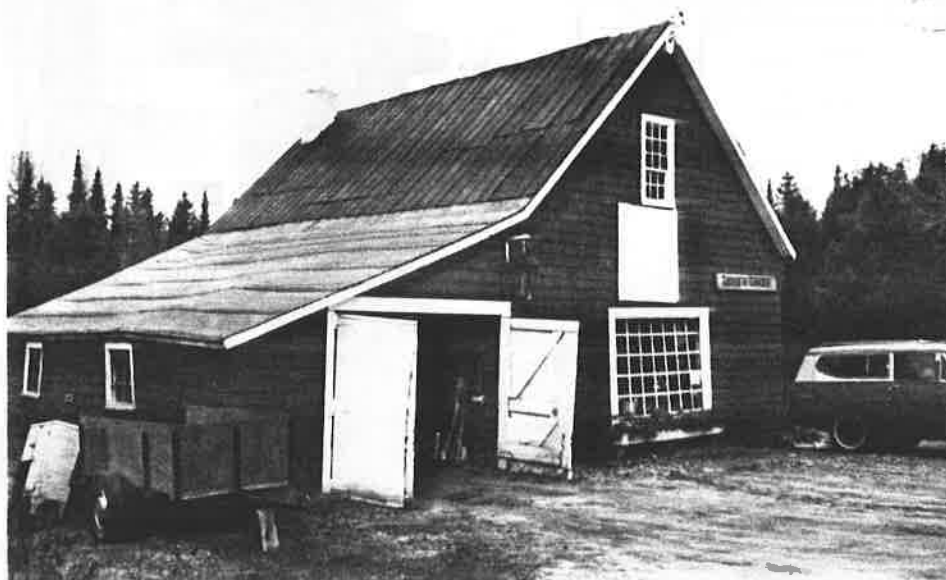
a.

The Weare-Lowry-Hartnett House is a good example of an early cape dwelling typical of the first wave of settlement on outlying hill farms. The existence of the early barn is rare in the survey. The property appears to have been deeded to J. Stevens in 1802 and occupied by W. Weare in 1861 and J. Lowry in 1892.

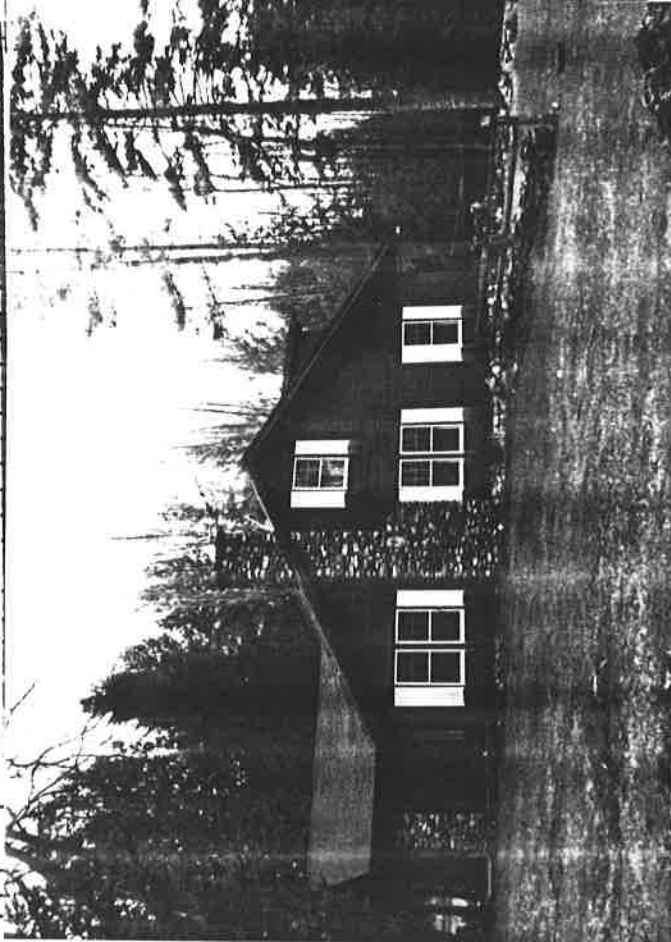
photographer facing NE, NW, NE  
 photograph date: 6/88  
 photo code(s): DN-43-88 #30-33

#77 Breed House - c. 1915, 1 1/2 story, Craftsman style house with large, gable roofed entrance porch. Fieldstone foundation, clapboard siding, asphalt shingle gable roof. Exterior, massive fieldstone chimney and fieldstone piers support large entrance porch. 6/1 sash, some paired, with flanking louvered wood shutters. Eaves supported by exposed rafters tails.

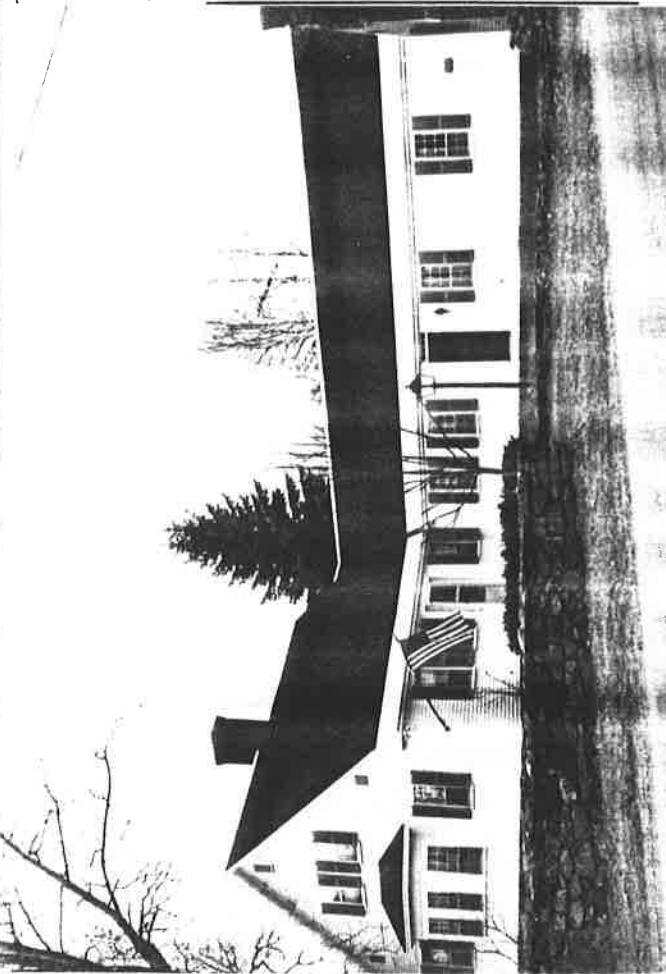
photo code(s): DN-43-88 #1

address Mountain View Road  
 property name "Stonecroft"  
 tax map/parcel no. 11 # 83  
 UTM ref Z 19 E 294810 N4918650 Lancaster  
 resource type (code) House  
 Dominant Style (code) Federal/Greek Revival  
 Secondary Style (code) \_\_\_\_\_  
 Condition (code) good  
 Construction Date (source) c.1825, c. 1845  
 Alteration Date(s) c. 1945

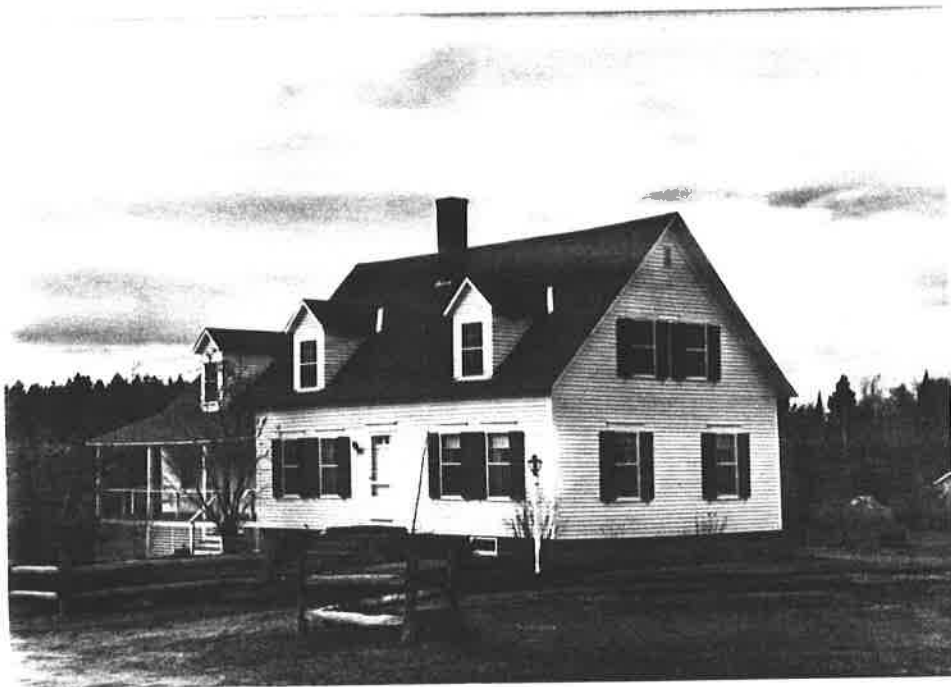
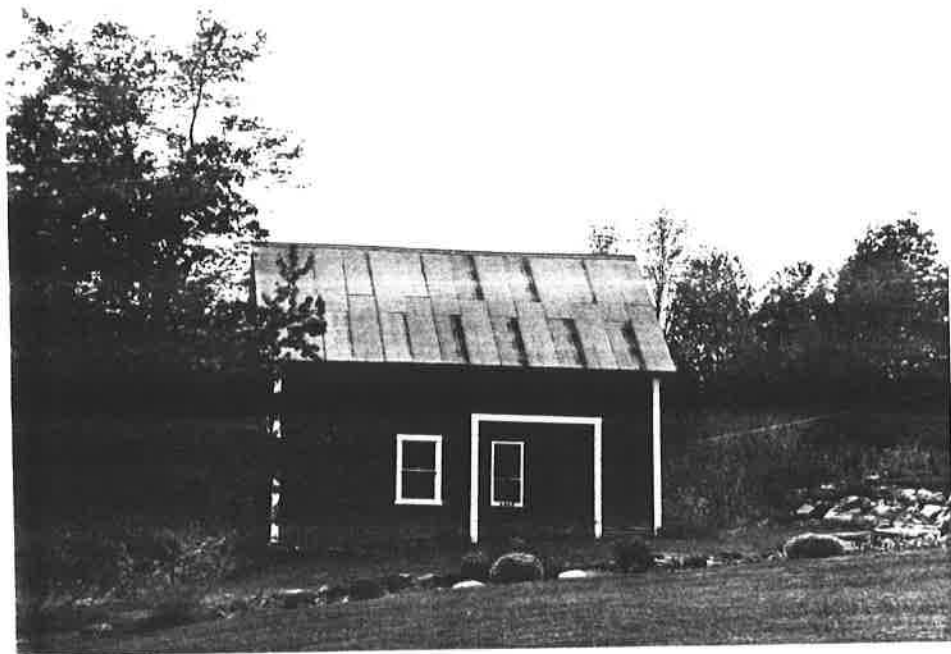
#82 Shallow-Fisher House - c. 1865, 1 1/2 story, 5x2 bay, vernacular house with 1 1/2 story wing. Brick foundation, clapboard siding, asphalt shingle roof. Plain cornerboards, frieze, simple eaves. 6/6 sash, flanking louvered wood shutters, cornice cap moldings. Gable dormers, brick chimney stack off-center front slope of roof. Wing has shed roofed porch.

The Shallow-Fisher House is a good example of a late outlying farmhouse representative of the continued agrarian settlement in Whitefield in a period dominated by industrial development.

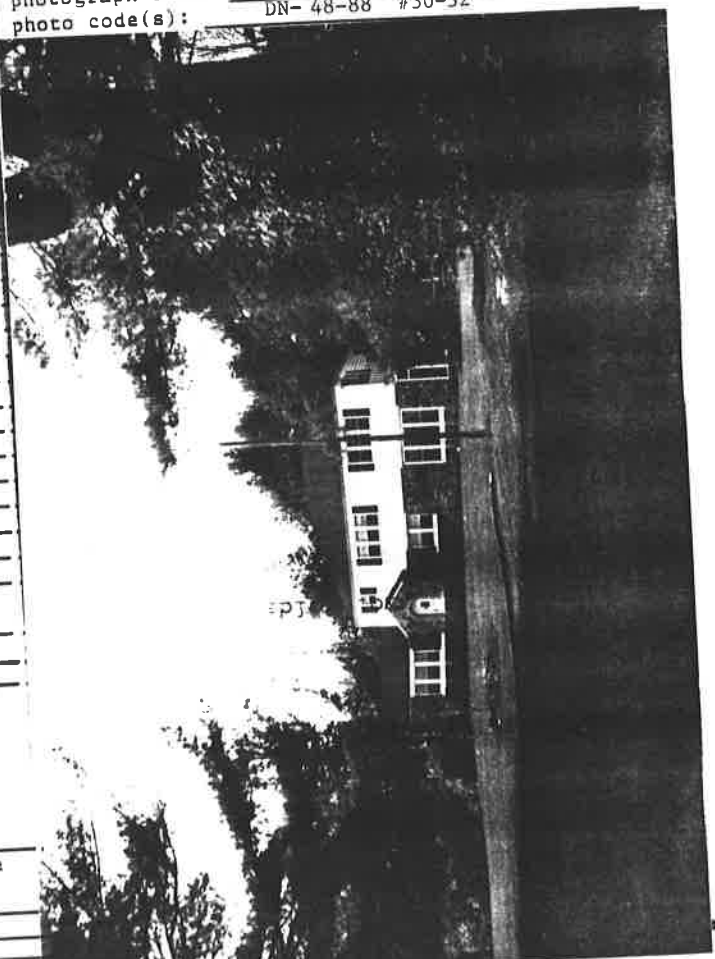
#83 Kominski House - c. 1920, 2 story, hip roofed, architect designed house with 1 story, gable roofed wing and 1 story, flat roofed porch wing. First story is fieldstone, second story is wood shingle with asphalt shingle roof. Gable roofed, stone enclosed entrance having semi-circular arched door with large iron hinges and small multilight sash. Sash is 6/1, most is grouped, varying sizes.
