DRAINAGE MONITORING REPORT

F107 - Seacoast Reliability Project

Newington, New Hampshire

04.0190967.00

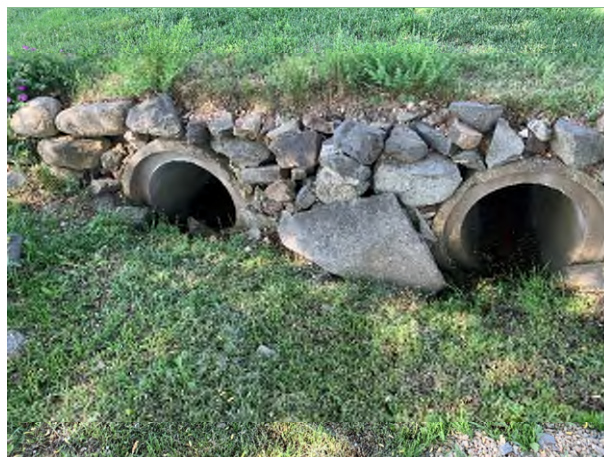
64 Gundalow -2 (Drainage Course)

Observations/Notes: Water pooled approximately 1" from end of culvert. No other surficial water observed in drainage course.

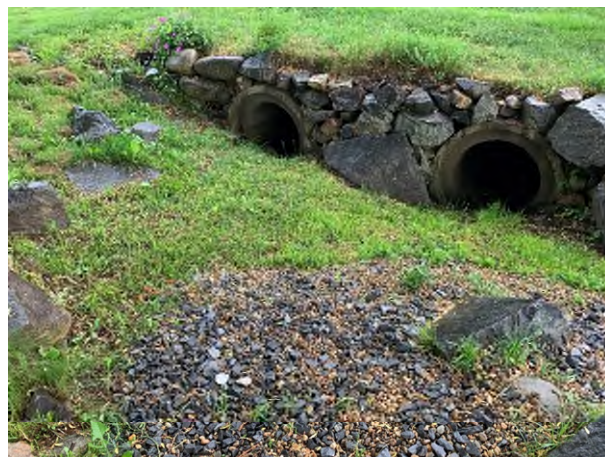
64 Gundalow -2 (Drainage Course)

Observations/Notes: Water pooled approximately 48" from end of culvert. No other surficial water observed in drainage course.

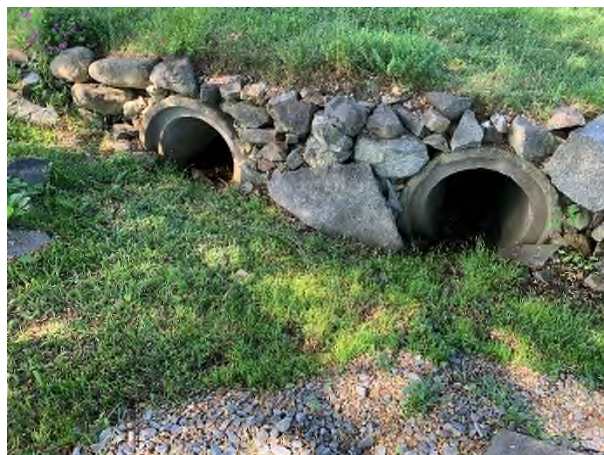
64 Gundalow -2 (Drainage Course)

Observations/Notes: Standing water approx. 3-4" deep, pooled approx. 18" from end of culvert. No other surficial water observed in drainage course.
