DRAINAGE MONITORING REPORT

F107 - Seacoast Reliability Project

Newington, New Hampshire

04.0190967.00

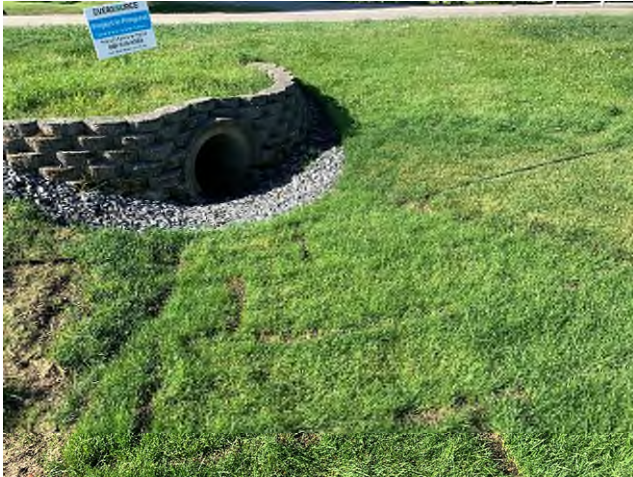
29 Gundalow -1 (Drainage Area)

- 29 Gundalow resident periodically watering new grass/sod. No activity at time of inspection
