DRAINAGE MONITORING REPORT

F107 - Seacoast Reliability Project

Newington, New Hampshire

04.0190967.00

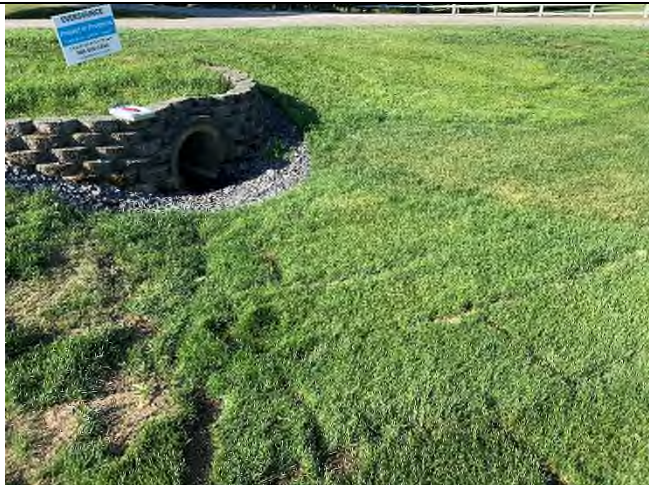
29 Gundalow -1 (Drainage Area)

- 29 Gundalow resident periodically watering grass/sod. No watering occurring at time of inspection.
