# DRAINAGE MONITORING REPORT

## F107 - Seacoast Reliability Project

### Newington, New Hampshire

04.0190967.00

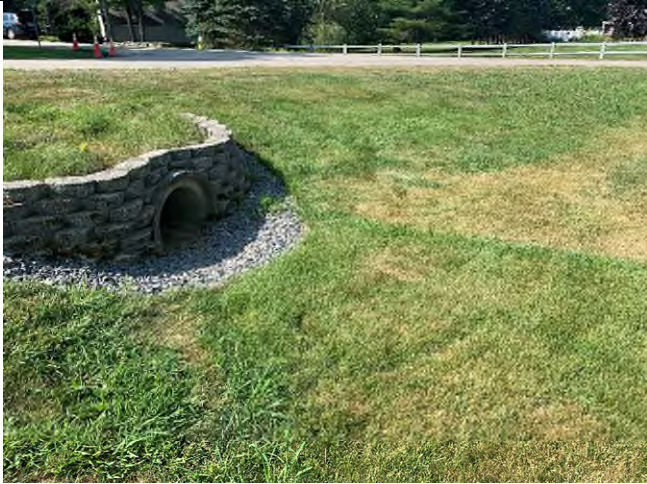
29 Gundalow - 1 (Drainage Area)

- Sod and loam/seed recently applied around drainage area. No watering occurring at time of inspection.

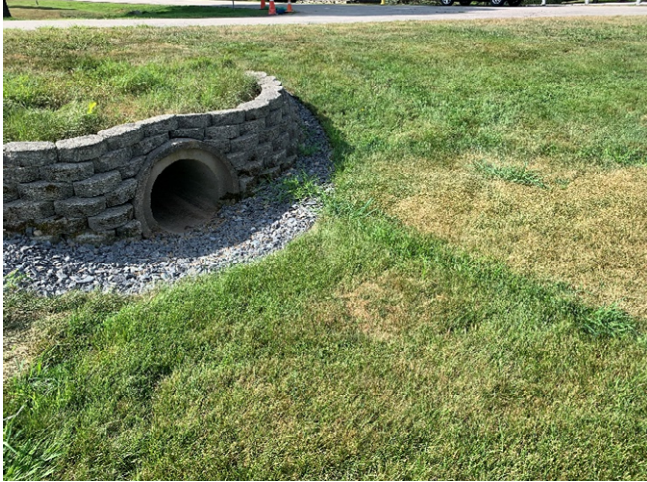
29 Gundalow - 1 (Drainage Area)

- Sod and loam/seed recently applied around drainage area is watered periodically. No watering occurring at time of inspection.

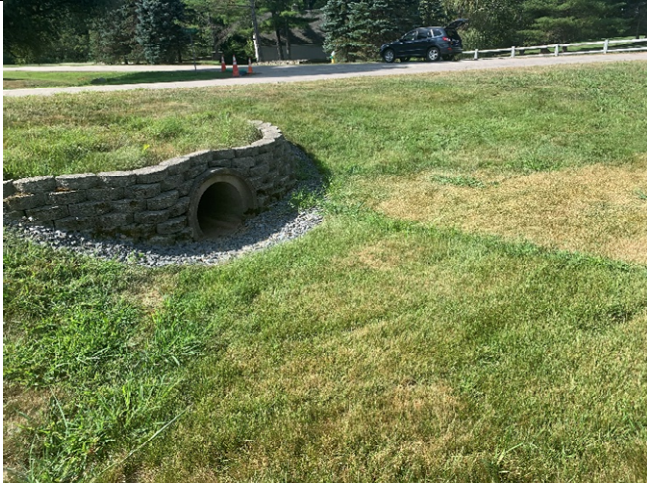
29 Gundalow -1 (Drainage Area)

- Sod and loam/seed recently applied around drainage area is watered periodically. No watering occurring at time of inspection.
