# DRAINAGE MONITORING REPORT

## F107 - Seacoast Reliability Project

### Newington, New Hampshire

04.0190967.00

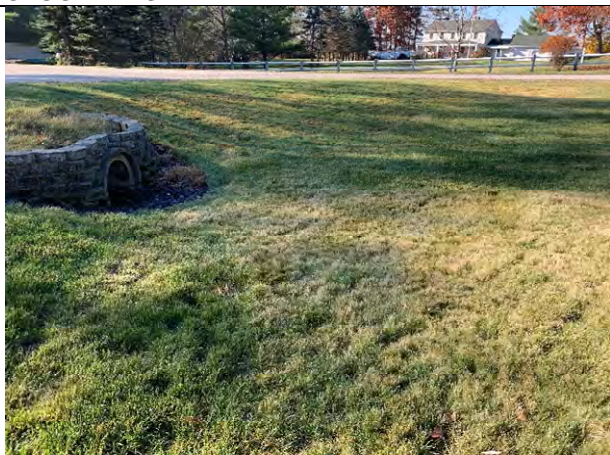
29 Gundalow - 1 (Drainage Area)

Status of surface water at the time of inspection?  Dry  Standing  Flowing

pH: ---

Observations/Notes:
