DRAINAGE MONITORING REPORT

F107 - Seacoast Reliability Project

Newington, New Hampshire

04.0190967.00

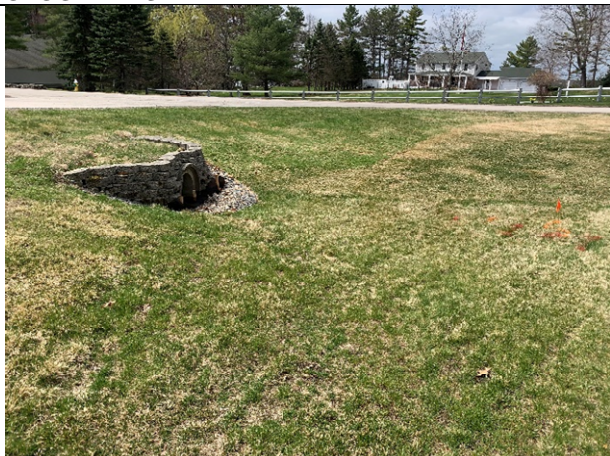
29 Gundalow - 1 (Drainage Area)

- Peat moss socks installed in drainage areas on 29 Gundalow Landing (1), 64 Gundalow Landing (3), and 4 Brickyard Circle (1) since 04/02/2021.
