### CONSTRUCTION MONITORING REPORT

Eversource Transmission Lines:  
**F107**

**Madbury, Durham,  
Newington, Portsmouth, NH**

**TYPE OF INSPECTION:**  Weekly  Storm Event  Incident  Corrective Action

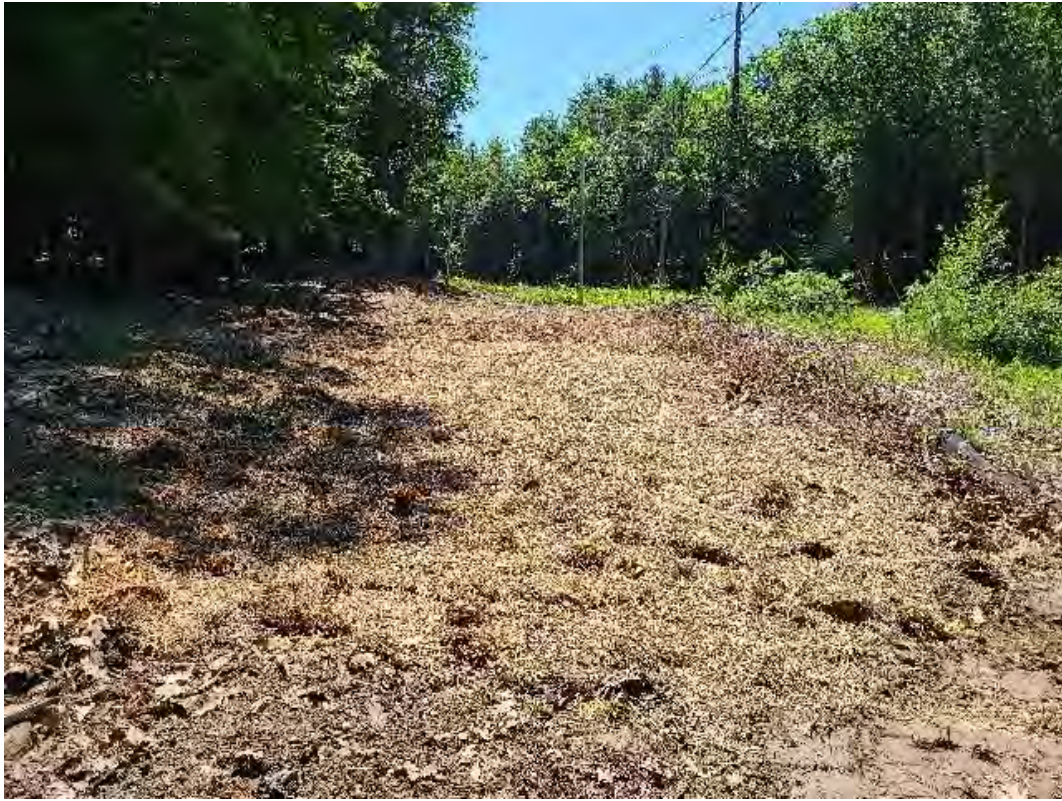
Fig 1: Removing gravel access road between Strs. 97-98. Viewing east. (07-02-20).

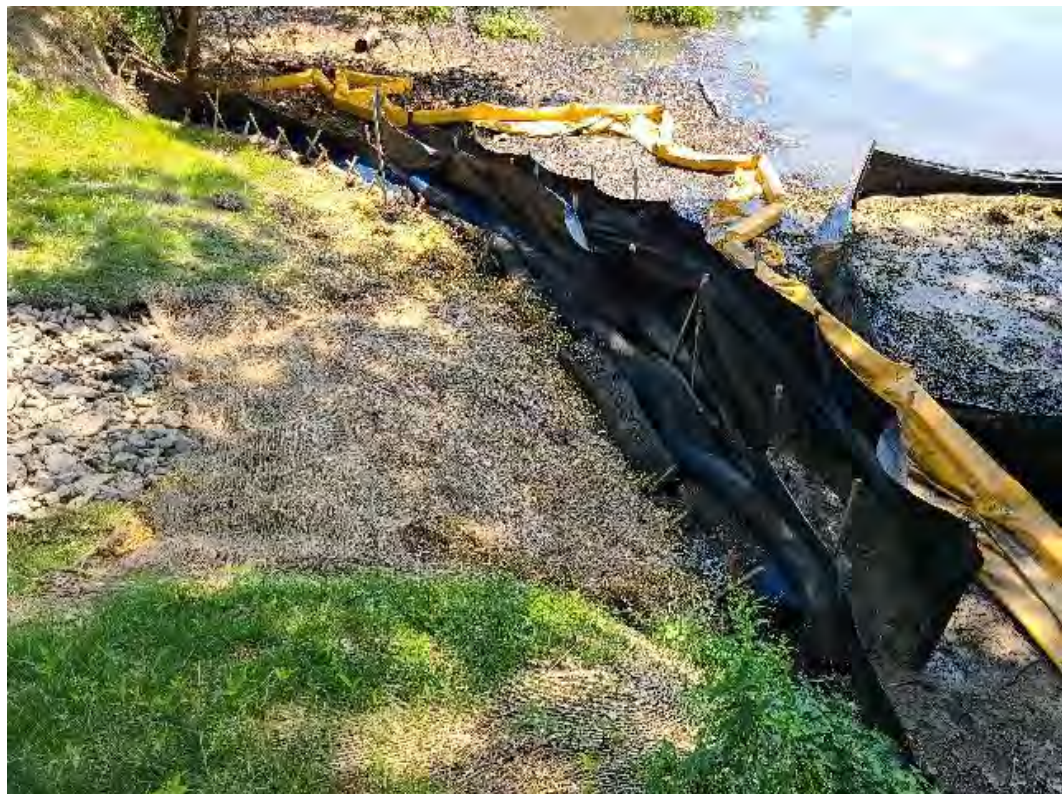
Fig 2: Temporary BMPs installed at toe of slope and intertidal zone at Gundalow landing/east side of the Bay. Viewing south. (07-02-20).

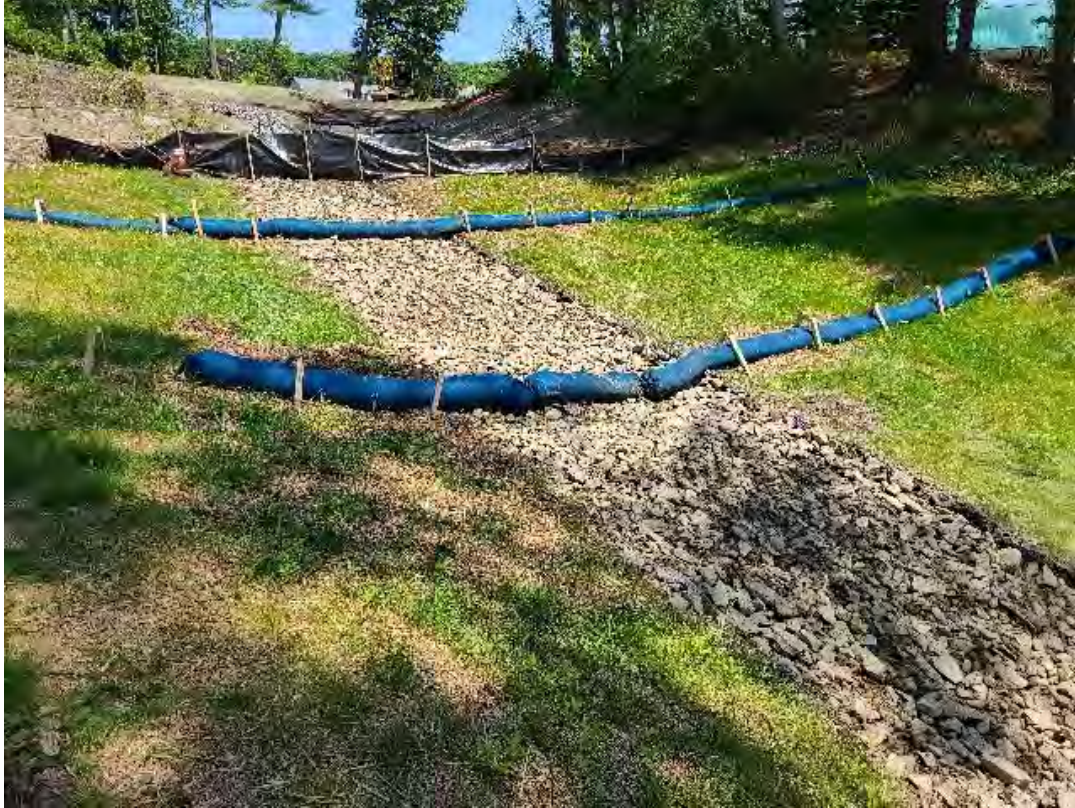
Fig 3: Temporary 6 inch stone installed in place of the small diameter gravel on path at Gundalow landing/east side of the Bay. Viewing east. (07-02-20).

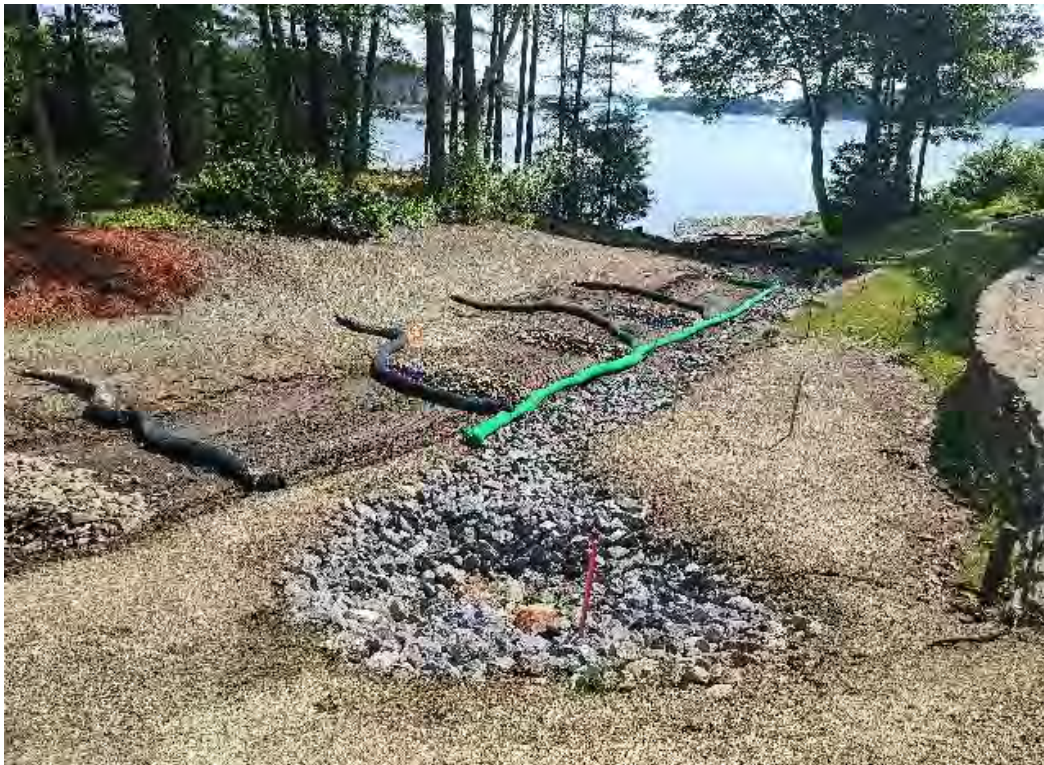
Fig 4: Drainage culvert & riprap swale-temporary BMPs installed on slope above manhole at Gundalow landing/east side of the Bay. Viewing south. (07-02-20).

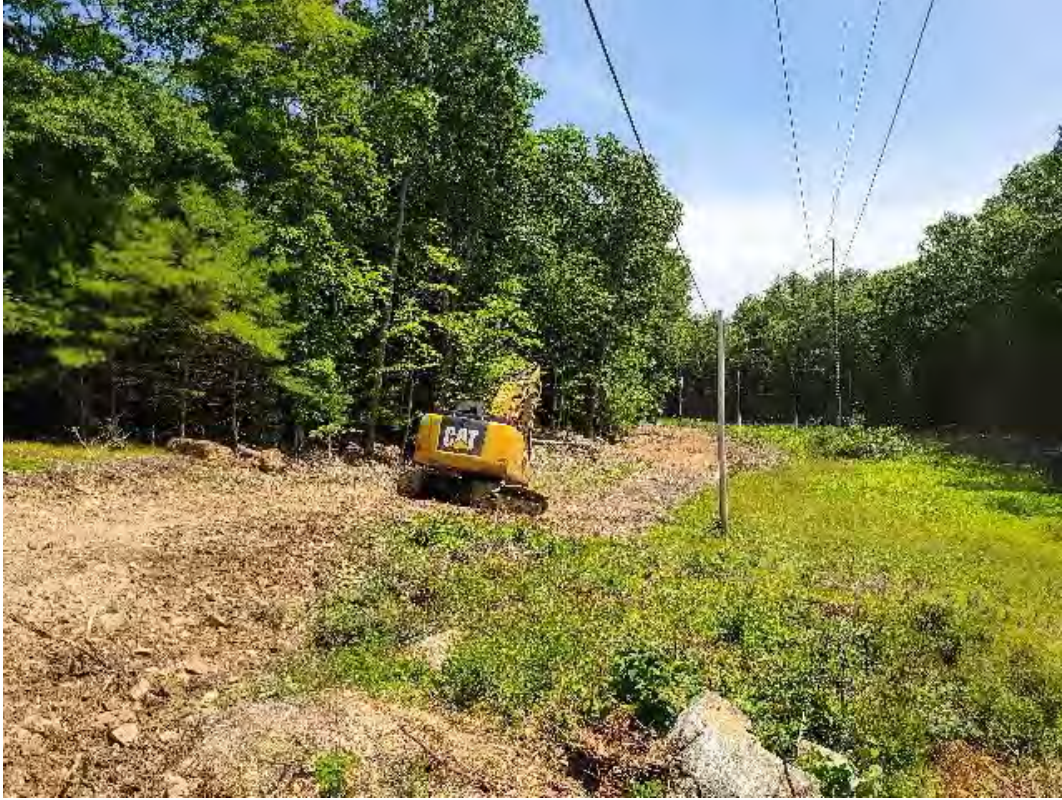
Fig 5: Crew continues to remove stone access road between Strs. 95-96. Viewing southeast. (07-07-20).

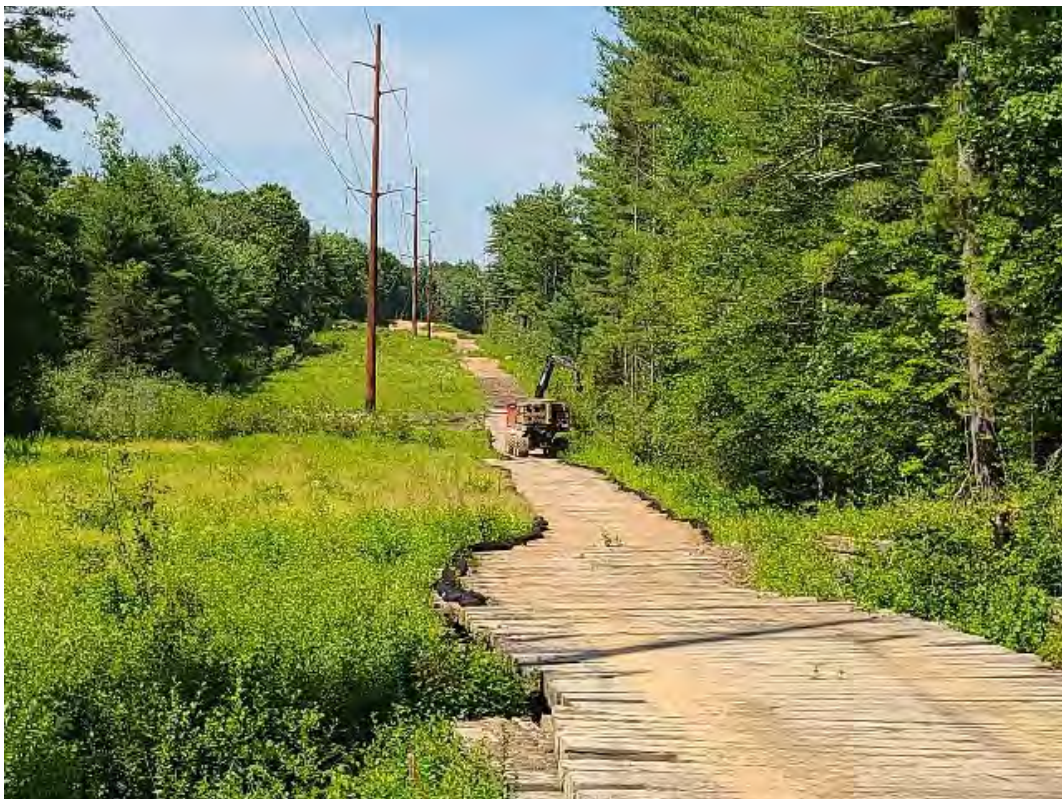
Fig 6: Crew removing timber mats used for access road between Strs. 44-45, through wetland DW58. Viewing north. (07-07-20).

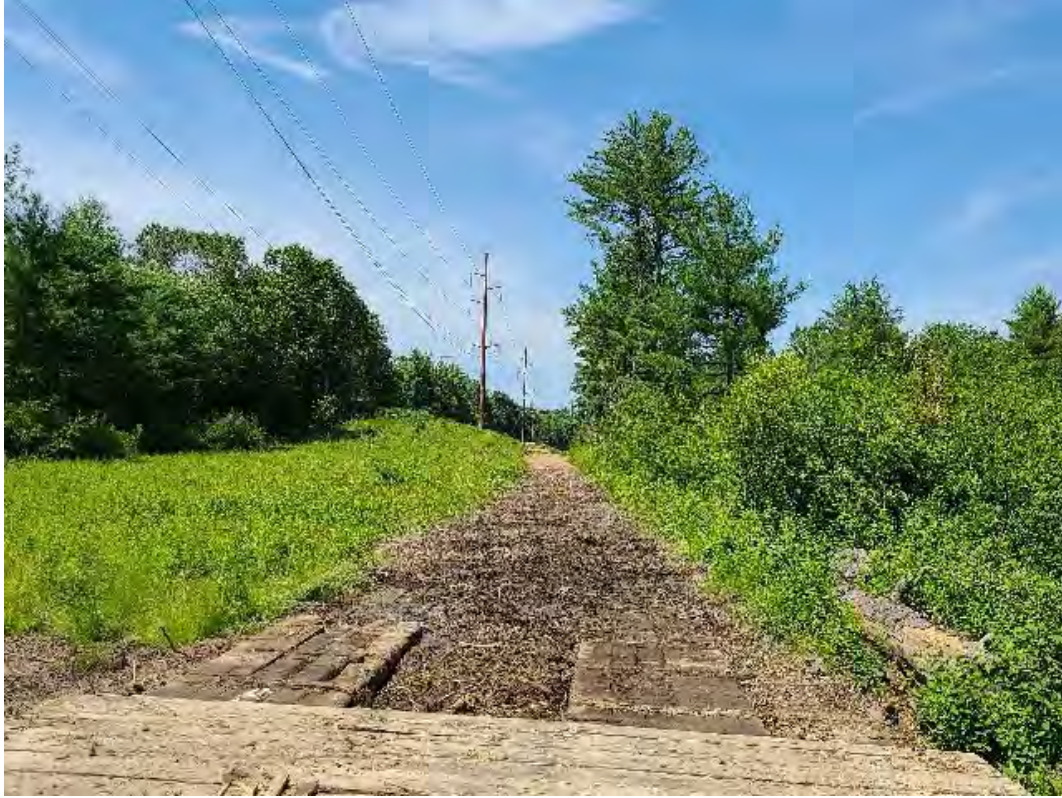
Fig 7: Crew removing timber mats through wetland DW58, between Strs. 44-45. Viewing north. (07-07-20).

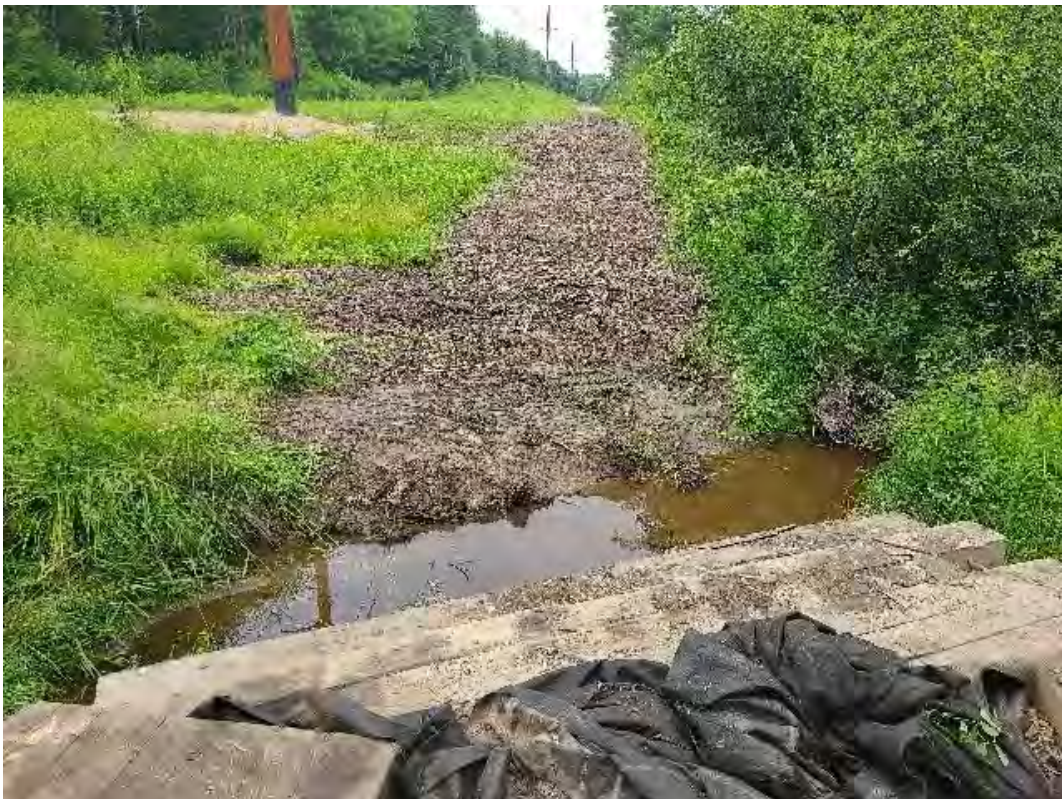
Fig 8: Removing timber mat bridge over stream DS60, between Strs. 44-45. Viewing north. (07-08-20).
