DRAINAGE MONITORING REPORT

Eversource Transmission
Line:

F107 - Seacoast Reliability Project

Durham, New Hampshire

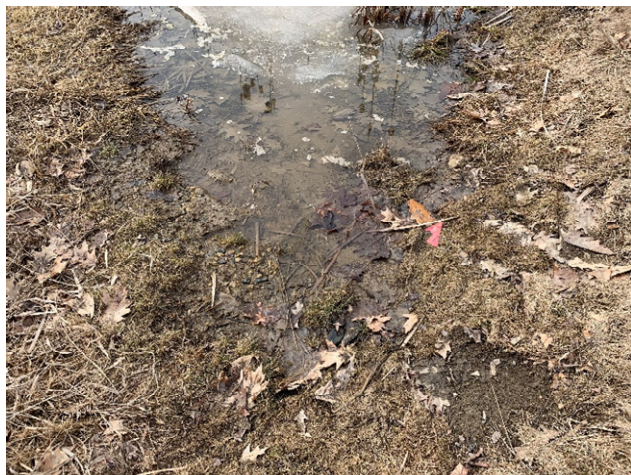
UNH Wetland - 1 (Stormwater Area)

Location: UNH Wetland – 1 (Stormwater Area)

pH: **8.4**

Observations/Notes: Approx. 1" standing water.

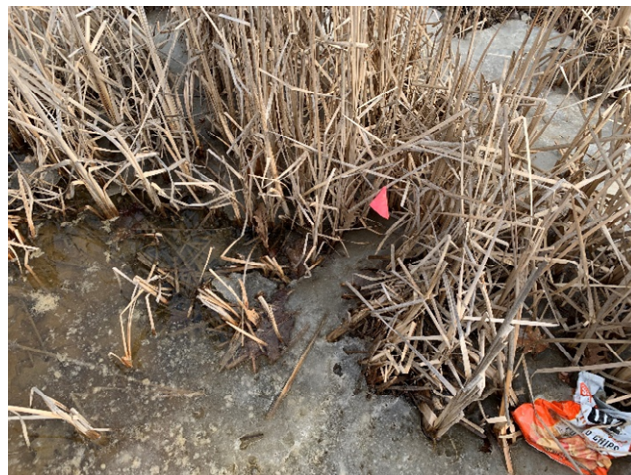
UNH Wetland - 2 (Stormwater Area)

Location: UNH Wetland – 2 (Stormwater Area)

pH: **7.2**

Observations/Notes: Approx. 2" standing water with some areas of ice.

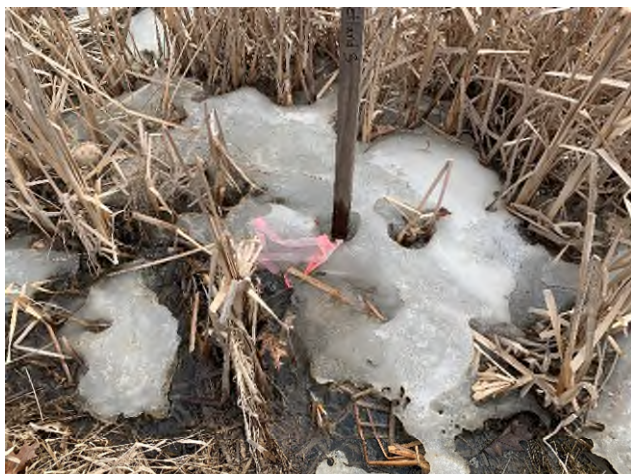
UNH Wetland - 3 (Cattail Wetland)

Location: UNH Wetland – 3 (Cattail Wetland)

pH: **7.6**

Observations/Notes: Intermittent ice with standing water approx. 4" deep.

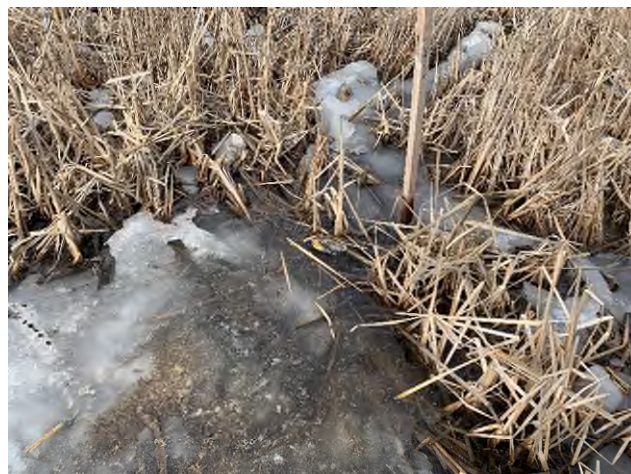
UNH Wetland - 4 (Cattail Wetland)

Location: UNH Wetland – 4 (Cattail Wetland)

pH: **6.7**

Observations/Notes: Intermittent ice with standing water approx. 6" deep.

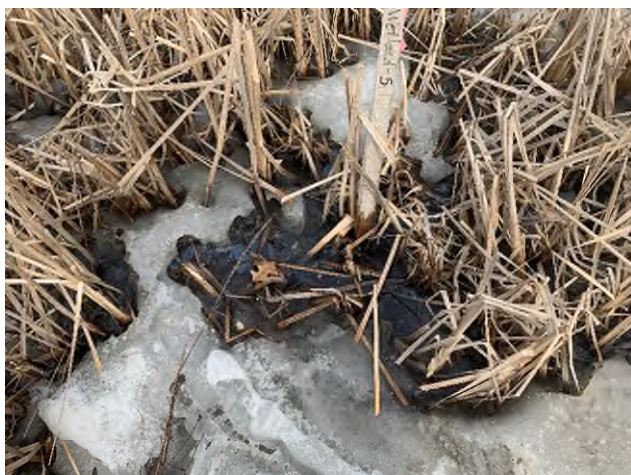
UNH Wetland - 5 (Cattail Wetland)

Location: UNH Wetland – 5 (Cattail Wetland)

pH: **6.8**

Observations/Notes: Intermittent ice with standing water approx. 6" deep.

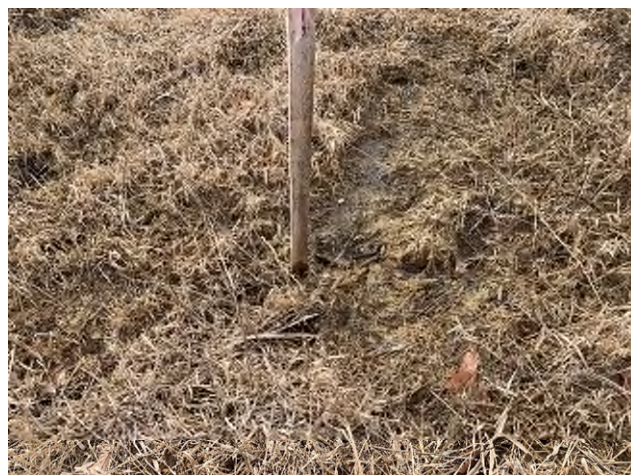
UNH Wetland - 6 (Cattail Wetland)

Location: UNH Wetland – 6 (Cattail Wetland)

pH: **6.7**

Observations/Notes: Small area of standing water less than 1" deep.
