# DRAINAGE MONITORING REPORT

## F107 - Seacoast Reliability Project

### Durham, New Hampshire

04.0190967.00

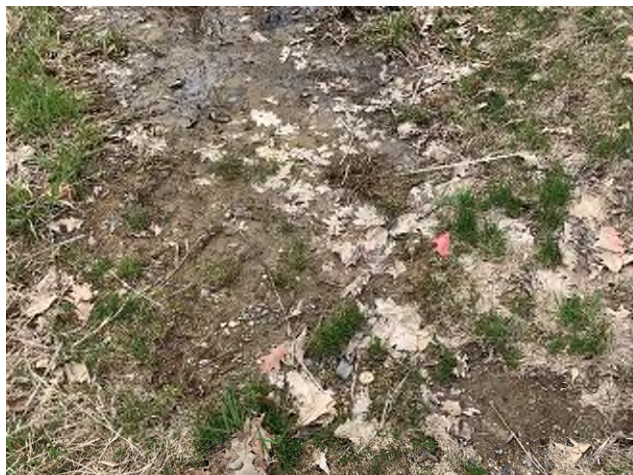
UNH Wetland - 1 (Stormwater Area)

**Location: UNH Wetland – 1 (Stormwater Area)**

Status of surface water at the time of inspection?  Dry  Standing  Flowing

pH: --

Observations/Notes: Dry

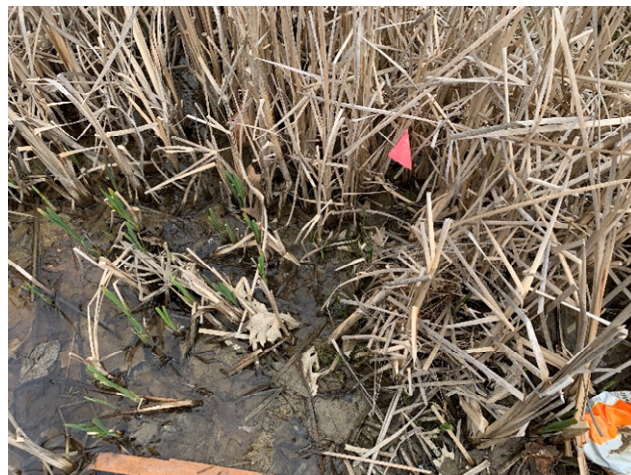
UNH Wetland - 2 (Stormwater Area)

**Location: UNH Wetland – 2 (Stormwater Area)**

Status of surface water at the time of inspection?  Dry  Standing  Flowing

pH: 7.1

Observations/Notes: Standing water approx. 2" deep, iron-oxide bacteria observed in vicinity.

- Organic sheen observed at all monitoring locations with standing water.

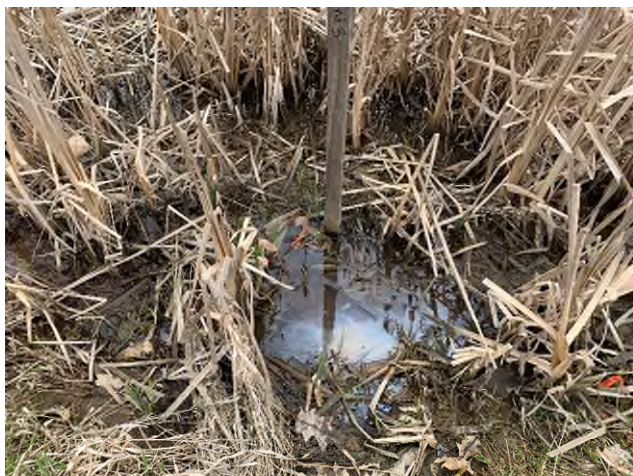
UNH Wetland - 3 (Cattail Wetland)

**Location: UNH Wetland – 3 (Cattail Wetland)**

Status of surface water at the time of inspection?  Dry  Standing  Flowing

pH: 6.8

Observations/Notes: Standing water approx. 3" deep.

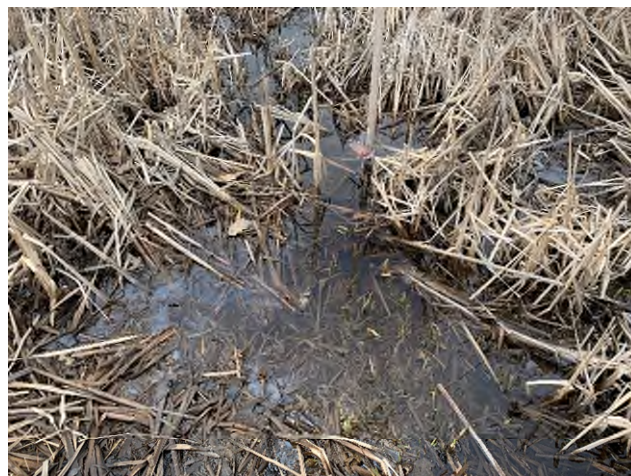
UNH Wetland - 4 (Cattail Wetland)

**Location: UNH Wetland – 4 (Cattail Wetland)**

Status of surface water at the time of inspection?  Dry  Standing  Flowing

pH: 6.9

Observations/Notes: Standing water approx. 5" deep.

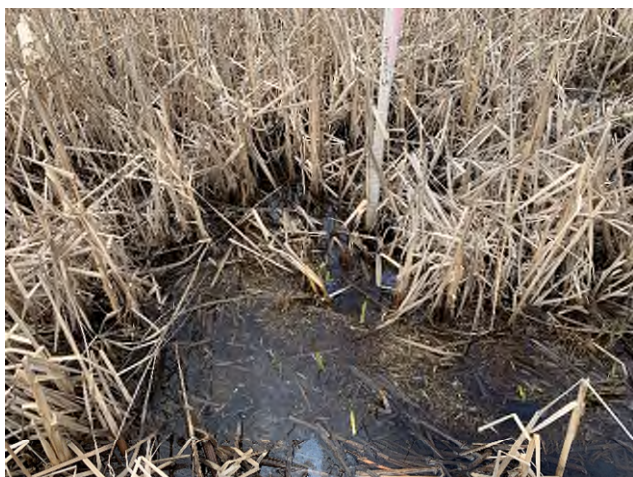
UNH Wetland - 5 (Cattail Wetland)

**Location: UNH Wetland – 5 (Cattail Wetland)**

Status of surface water at the time of inspection?  Dry  Standing  Flowing

pH: 6.7

Observations/Notes: Standing water approx. 5" deep.

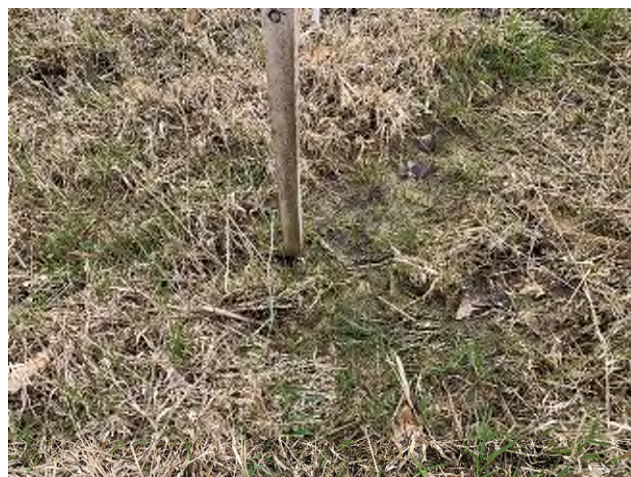
UNH Wetland - 6 (Cattail Wetland)

**Location: UNH Wetland – 6 (Cattail Wetland)**

Status of surface water at the time of inspection?  Dry  Standing  Flowing

pH: --
