Subject **Daily Monitoring Report**

Project Independent Environmental Monitoring, Little Bay Submarine Cable Installation, Seacoast Reliability Project

Project No. E2X85301 **File** Daily Monitoring Report_SRP Little Bay IEM_Cable 3 Install Day 1 11-6-19

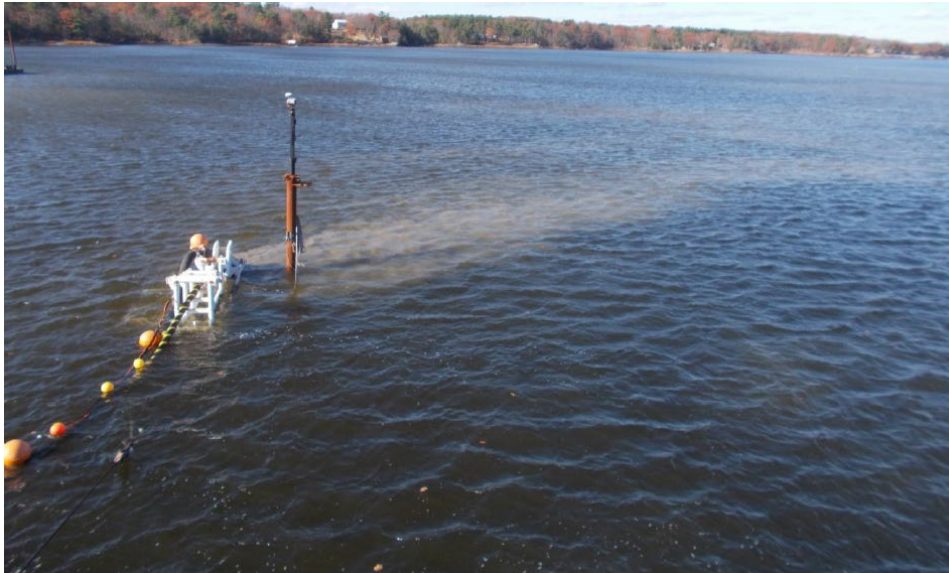
1300h – Normandeau reports 52 NTU at nearfield station (#12).

Jet plume observed from work boat on western tidal flat. Photo courtesy of Durocher Marine.

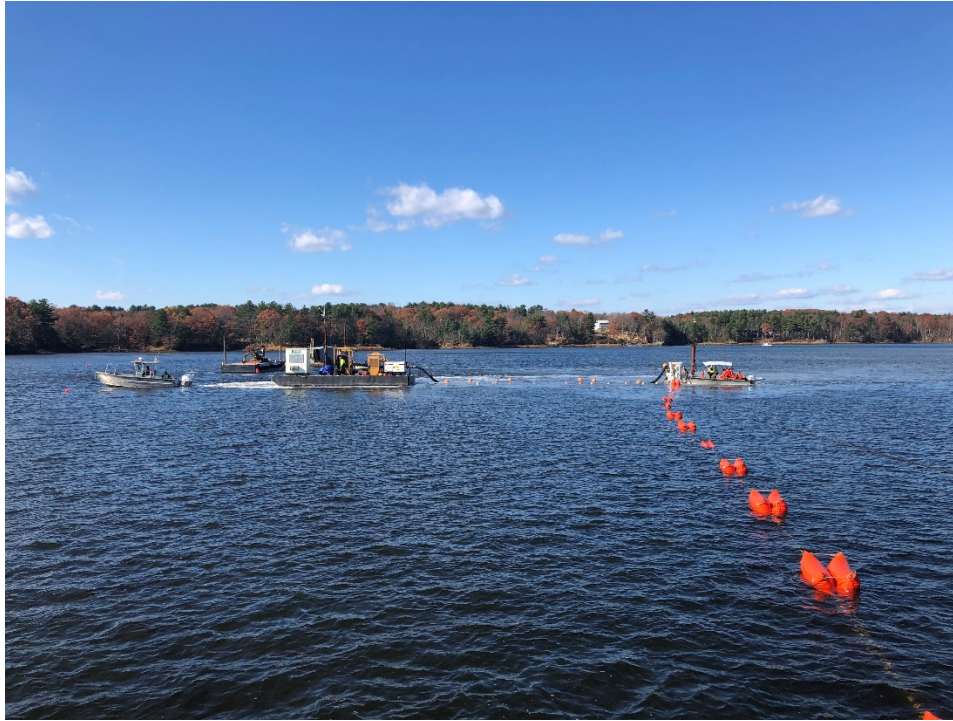
Cable 3 Installation. Cable with float bags tended to by divers and work boat removing bags prior to cable entering plow bell mouth. Pump barge tied to 2nd work boat and moved with jet plow progress. Small spud barge with mini excavator in the background was used to tether to the cable for alignment purposes.

Item	
1	IEM instructed Eversource and Durocher about corrective action regarding all work vessel movements during Cable #3 Installation to minimize turbidity. IEM provided DES a list of corrective actions prior to the approval for Cable 3 operations. This message was reiterated to the Operations Team prior to and during Cable 3 Installation activities.
2	IEM contacts Normandeau and instructs them to keep vessels away from anchor wires and pump barge. One of the vessels lost GPS signal and could not locate water quality station and drifted into area of anchor wire and pump barge. Vessel was informed and recovered to its intended position. No incident resulting.
