August 17, 2016

Mr. Bisbee,

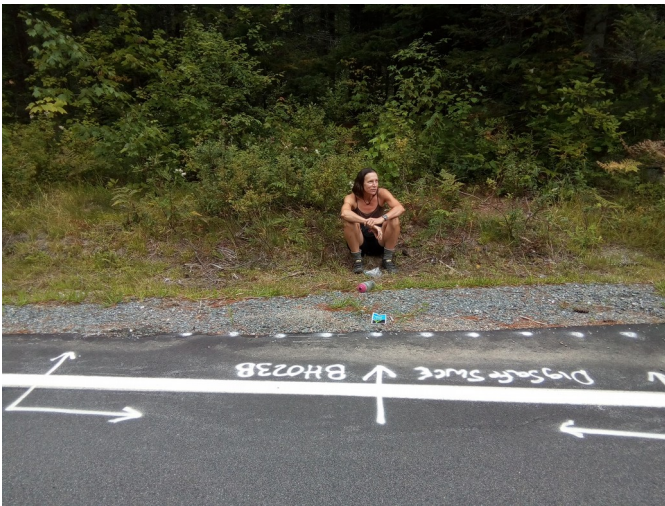
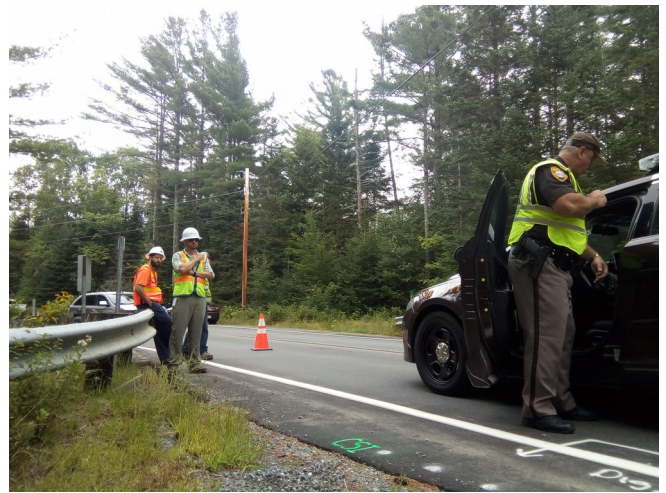
I engaged in a peaceful act of passive resistance to your attempt to bore Hole 23B and dump your used drilling slurry at the site, possibly contaminating soils, wetlands, the watershed and the underlying aquifer. I did this by sitting on the bore-hole site near the Ham Branch river, preventing the drilling rig from being unloaded there. The crews moved to a hole on the other side of the road within sight. I napped for about an hour before you directed the crews to call in another officer to bring me to the local police station forcibly if I refused to leave, which I did. Officers Moorhead and Tyler were very polite and would probably support my assertion that I did not cause a risk of harm to the public, the drilling contractors or myself.

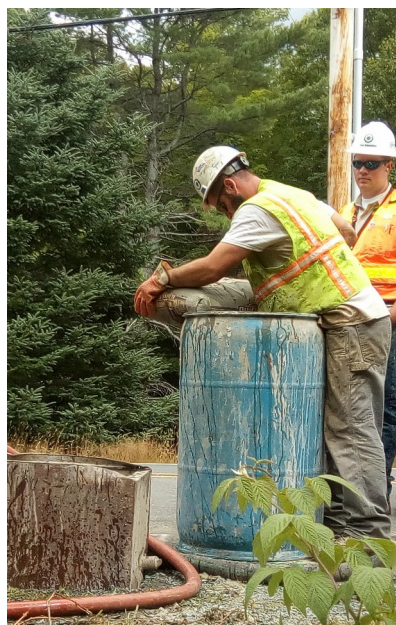
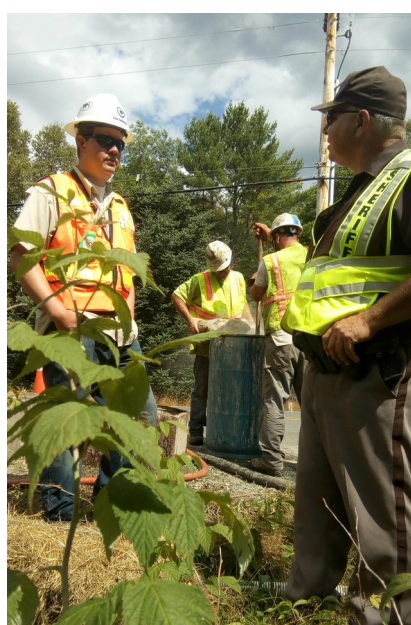
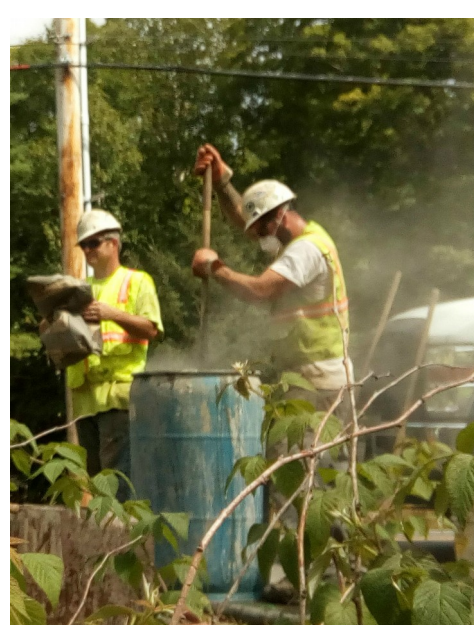
You state that bentonite and Portland cement pose no environmental risk, yet bentonite is harmful to aquatic life and the Portland cement MSDS states “May cause long-term adverse effects to the aquatic environment. Do not allow undiluted product or large quantities of it to reach ground water, water course of sewage system. Must not reach bodies of water or drainage ditch undiluted or un-neutralized.” In addition, the workers are being allowed to use the product without adequate protection, as seen below. A hardware store dust mask is not a respirator. Sunglasses are not safety glasses. The man holding the bag is not wearing gloves. Where is the eye-wash station? These are not homeowners doing a weekend job. They are handling these materials six days a week.

The Material Safety Data Sheet for the Portland cement being used above states:

**Precautions for safe handling:** Ensure good ventilation/exhaustion at the workplace. DO NOT BREATHE DUST. In dusty environments, the use of an OSHA, MSHA or NIOSH approved respirator and tight fitting goggles is recommended. Wear appropriate PPE (See section 8). Do not mix with other chemical products, except as indicated by the manufacturer. Do not get in eyes, on skin or clothing. Good housekeeping is important to prevent accumulation of dust.

Watching the operation without intervening is a clean Crux employee.

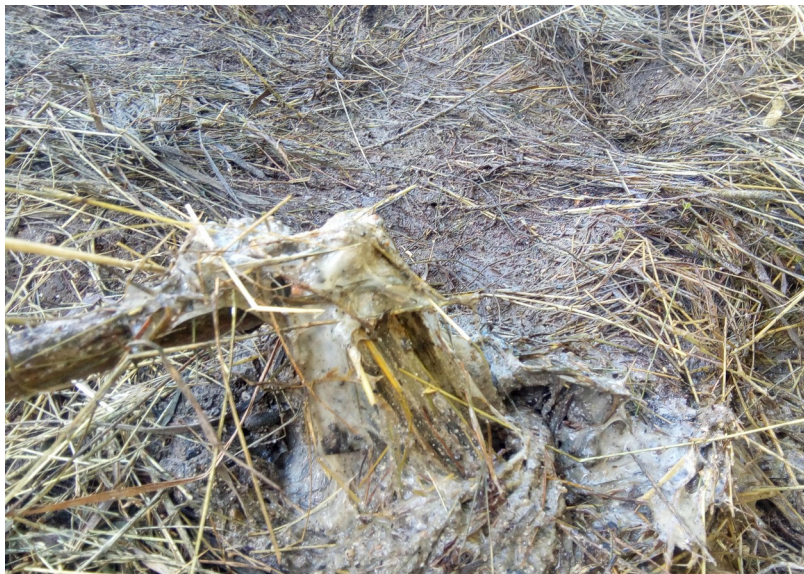
Your second to last paragraph: “the S.W. Cole personnel shown in the photographs are wearing appropriate Personal Protection Equipment.

Is a Trash Bag is appropriate Personal Protection Equipment when handling bentonite slurry mixed with Accus-Vis,? Bentonite MSDS advises “avoid contact with skin, eyes and clothing...Use appropriate protective clothing...wear safety goggles or glasses to prevent against exposure...Prevent from entering sewers, waterways or low areas.”

MSDS for Accu-Vis states that it is harmful by inhalation and contact with skin.

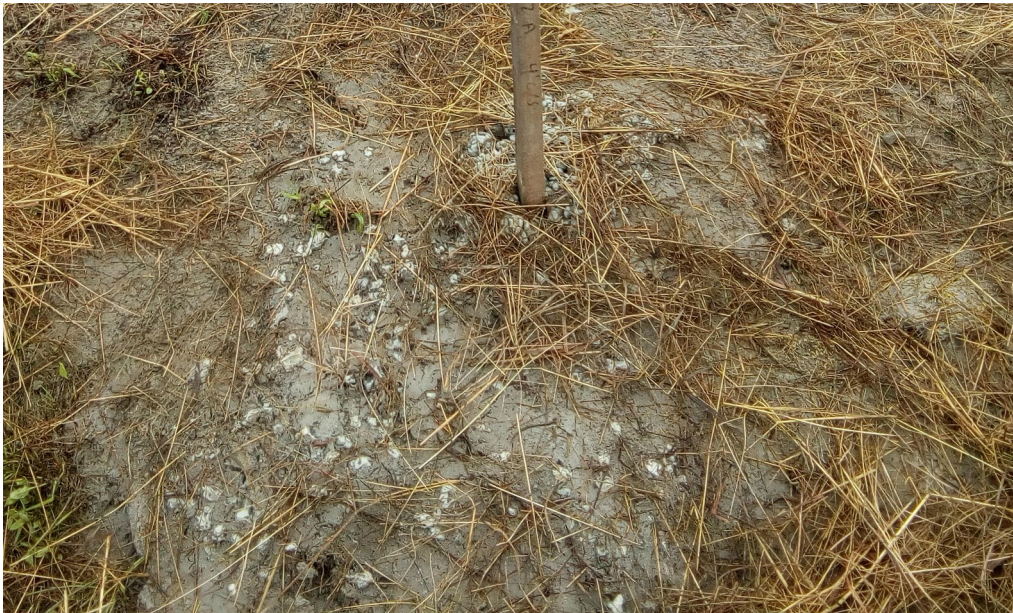
HolePlug appears to be what is piled around a bore hole drilled recently in Easton. The data sheet for HolePlug states:

- The subsurface environment that the respective bentonite sealing material or grout is to be placed into should always be taken into consideration when selecting the appropriate material to compose the well seal. If the formation water chemistry has a total hardness of greater than or equal to 500 parts per million and/or a chloride content of greater than or equal to 1500 parts per million the use of a bentonite material may not be appropriate for this environment. In the event that questions regarding subsurface environments arise it is always best to consult your local Baroid IDP representative to determine if the Baroid product of choice is appropriate for the given conditions.

I request test results showing the water chemistry results for all sites where HolePlug was used. In addition, the product appears to have been piled at the top of the hole and covered with gravel and hay, rather than inserted in the hole.

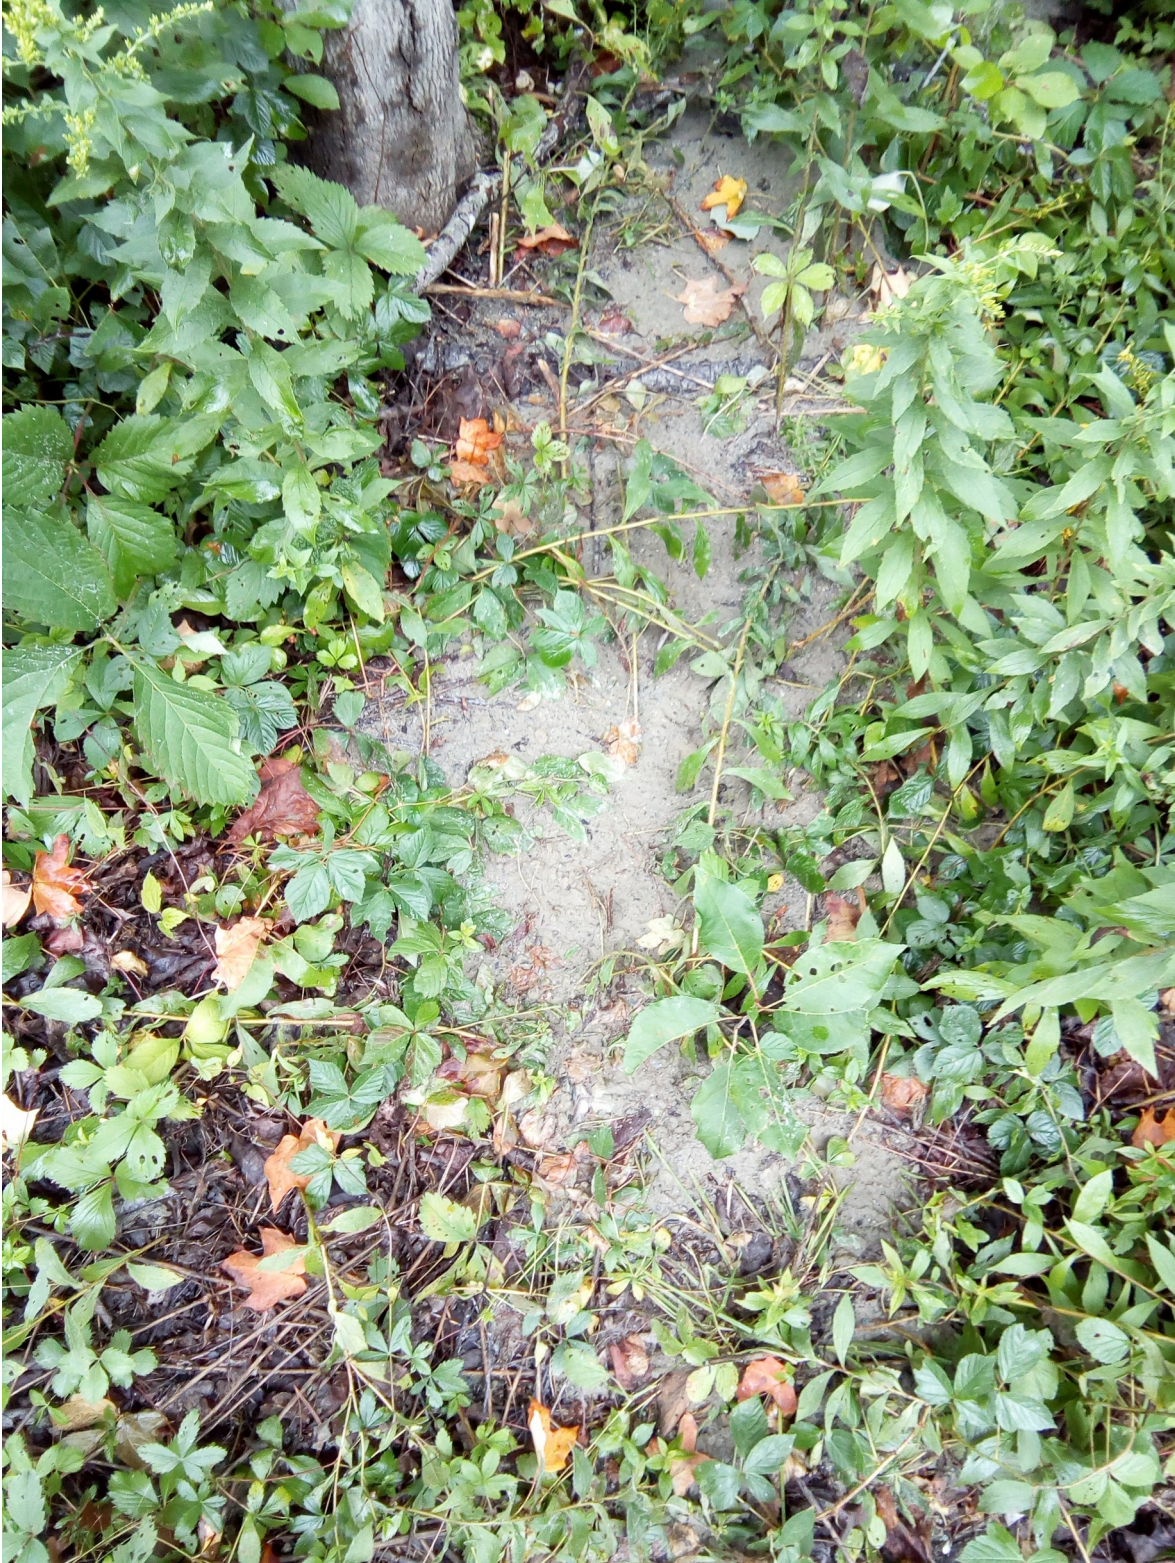
“The contractors do clean up the location of each drilling location when they are done, but some material unavoidably remains on the surface.” Dana Bisbee 8/10/16

Below: One of several bore hole sites with dumped drilling slurry in the woods. This dump includes several other piles hidden beneath the undergrowth. (White Mountain National Forest)

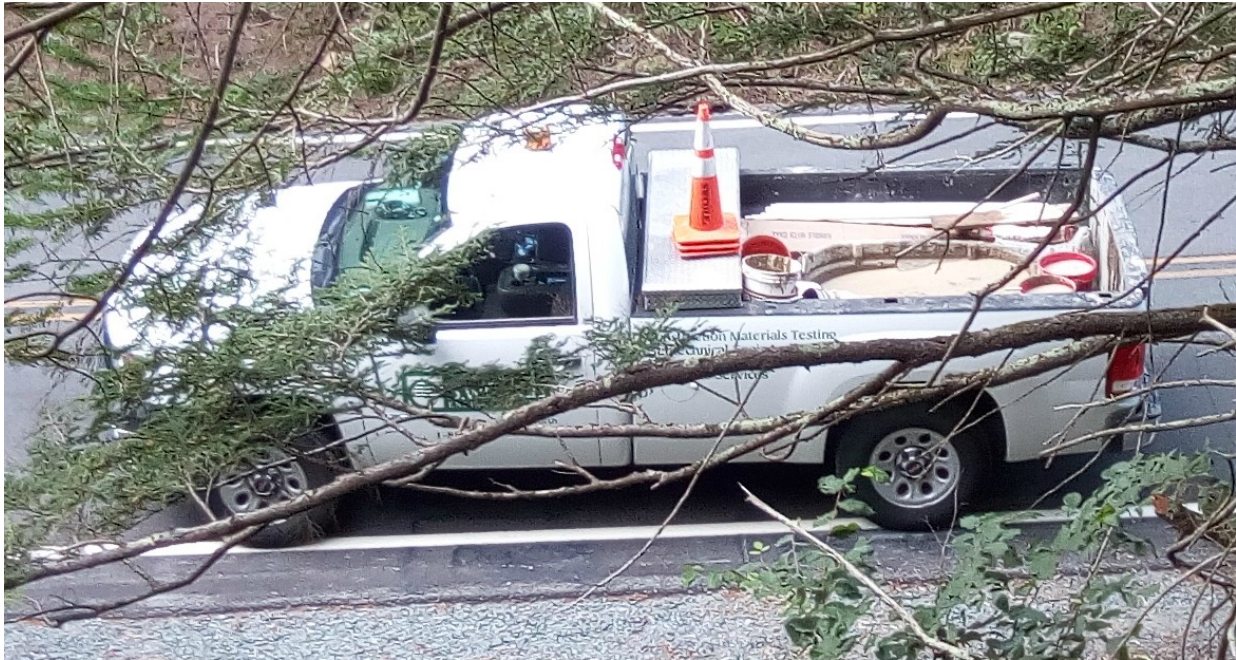
I watched the team below collect almost all the bentonite slurry for removal after drilling. They seemed at a bit of a loss as to how to bring it back though. Below: Tub of boring slurry in back of truck along with two five gallons buckets of slurry. This appears to be a new method in response to surveillance. Removing all slurry from the site is BMP but I think the transportation method is not.

And where was the slurry disposed of? Truck headed through WMNF.

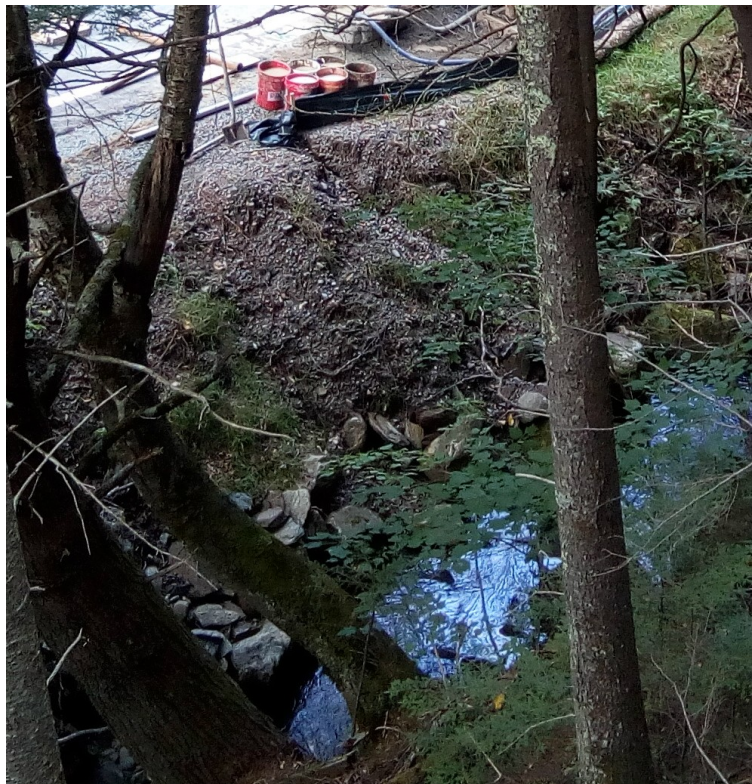
Mixing tub and five buckets of slurry above stream. No hay, inadequate containment measures. Easton Selectboard requested this location not be bored.
